AIRCRAFT ACCIDENT REPORT 1/2010

Air Accidents Investigation Branch

**Report on the accident to
Boeing 777-236ER, G-YMMM,
at London Heathrow Airport
on 17 January 2008**

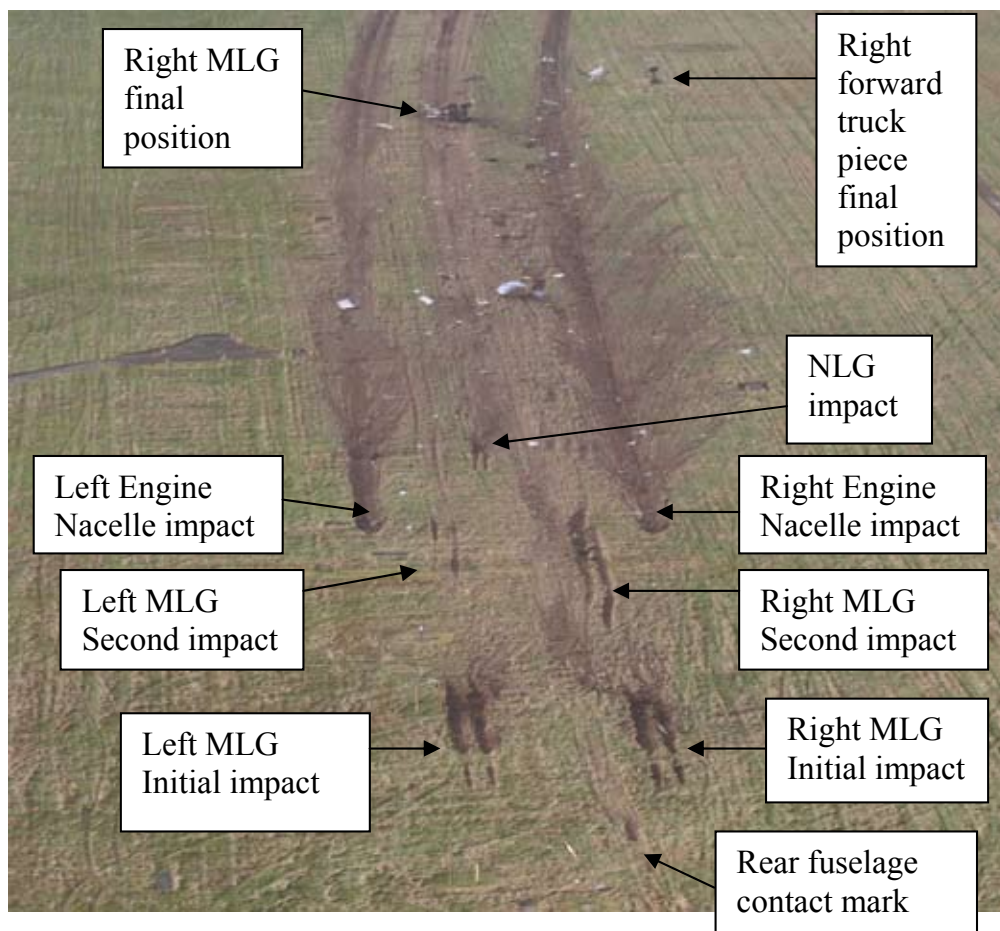
Approximately 40 m beyond its initial contact, the left engine struck the concrete cover of the southern inspection pit, which caused severe disruption to the front and lower engine area and the failure of the majority of its fan blades.

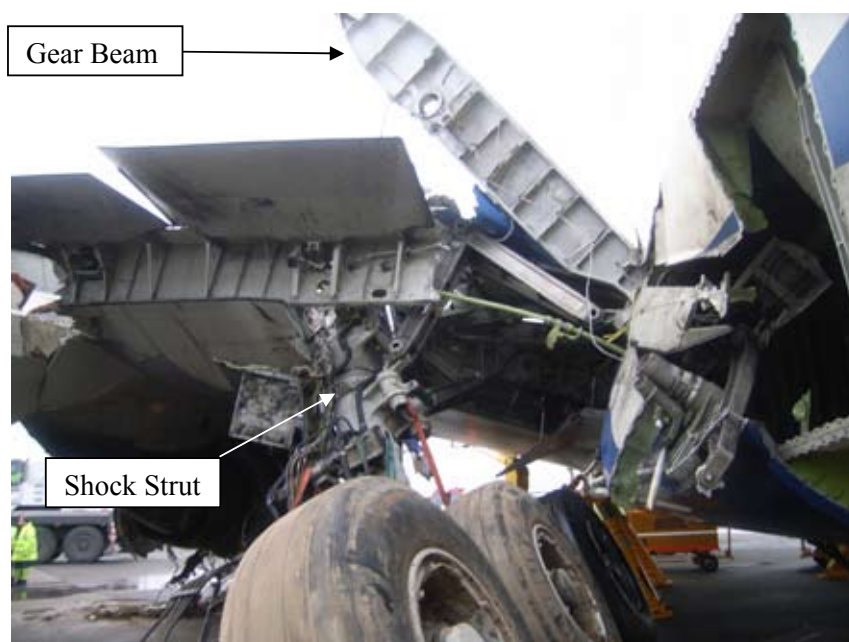
Figure 25

The truck beam had evidence of damage due to over-travel in the truck pitch-up direction. There was no visible damage to the shock strut or centre axle

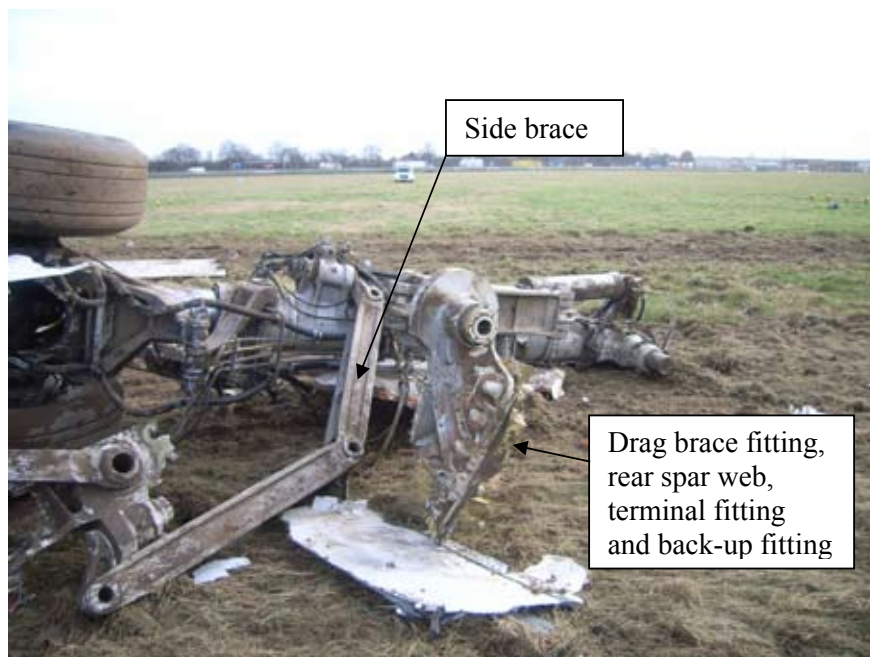
Figure 26

During the subsequent ground slide the right MLG had separated from the aircraft, rupturing the rear wing spar web. The drag brace support fitting, together with portions of the rear spar web, rear terminal fitting and the internal back-up fitting remained attached to the right main landing gear around the drag brace fitting. Examination of the fracture surfaces indicated an overload in the aft direction.

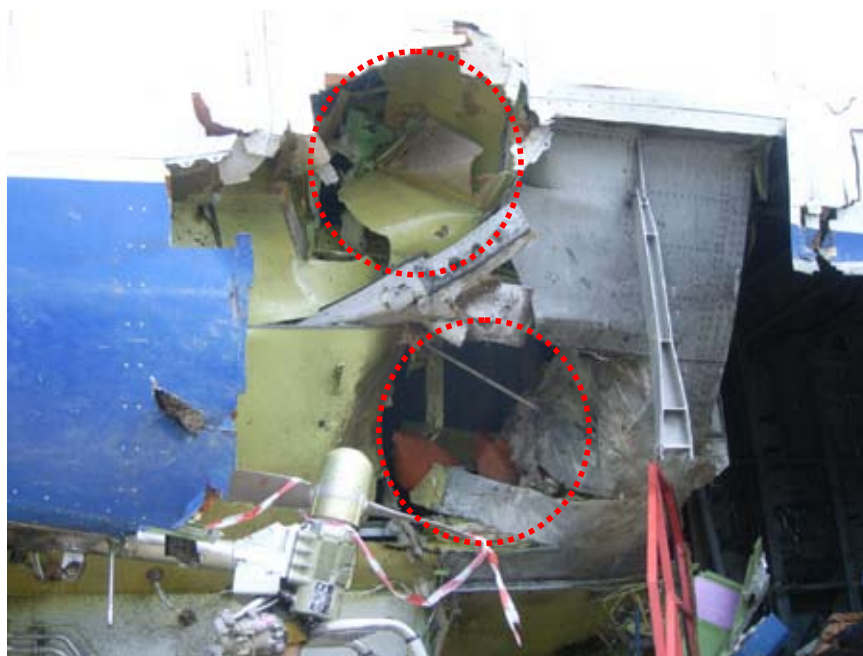
Figure 29

The two front wheels of the right MLG, together with the forward section of the truck beam ahead of the centre axle became detached and impacted the right side of the fuselage.

View showing damage to right fuselage aft of the MLG bay.
(Dotted lines indicate impact marks from the rear two wheels of the truck beam)

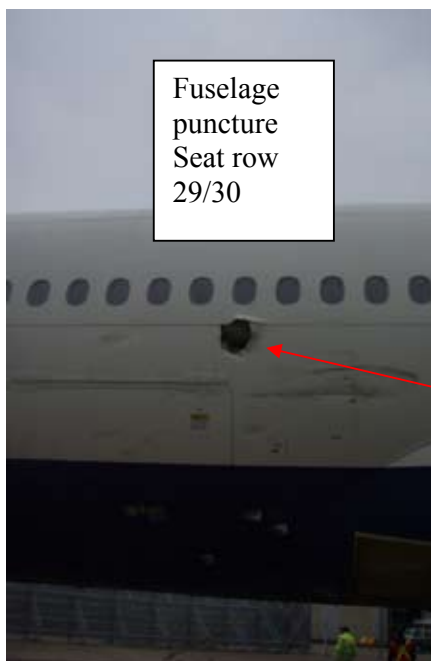
Figure 30

Right side of fuselage showing damage at seat rows 29/30

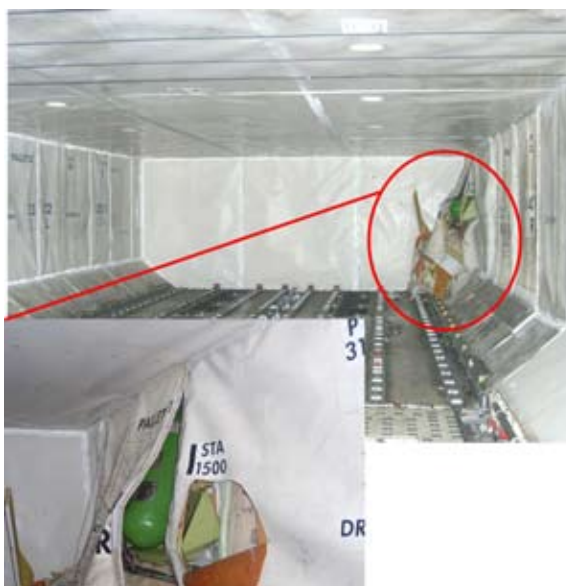
Figure 32

The impact and penetration of the forward right side of the rear cargo bay by the right landing gear tore one of the oxygen cylinders from the cabin oxygen supply manifold, rupturing the manifold pipe (Figure 32). This allowed all the remaining cabin oxygen cylinders to vent to atmosphere.

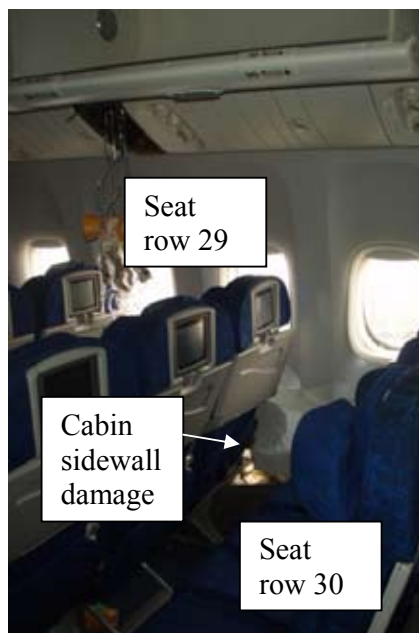
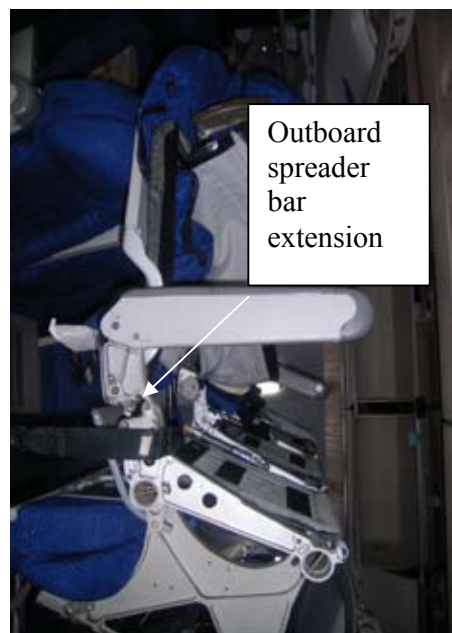
The right MLG forward truck beam and its wheels had punctured the right side of the fuselage adjacent to seat rows 29-30, at the height of the seat armrest (Figures 33 and 34). This had breached the fuselage outer skin, insulation blankets and the cabin lining panel. The sidewall lining had been pushed into the cabin, resulting in the injury to the passenger seated in 30K and the failure of the outboard spreader bar extension of seat 29K.

Cabin damage at rows 29/30

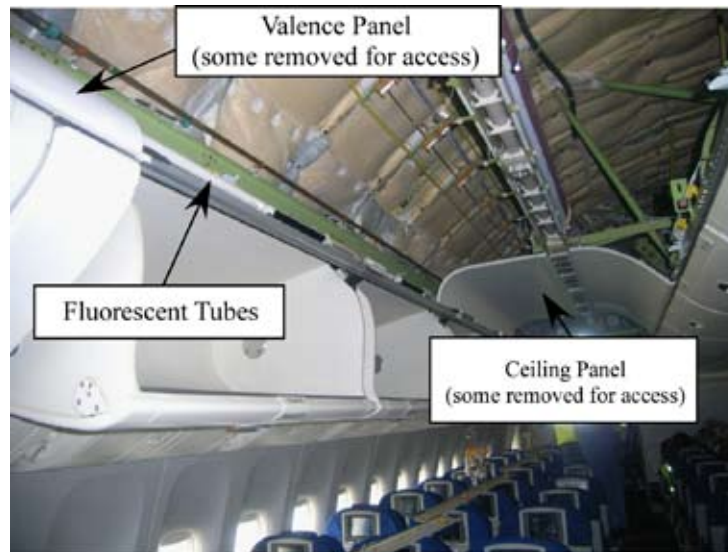
Figure 36

A further, detailed examination showed that on the right side there were eight fluorescent tubes missing. Of these, five had separated from the fixtures but were intact and were lodged above the overhead bins behind the valence panels. Three fluorescent tubes had broken. On the left side there were ten fluorescent tubes missing; five tubes had separated but were intact and five had broken. Three of the fixtures were damaged but the tube retaining end fittings were still functional. The gap between the ceiling panel and the valence panel contained numerous fragments from the fluorescent tubes.

Overhead lighting, showing loose fluorescent tubes

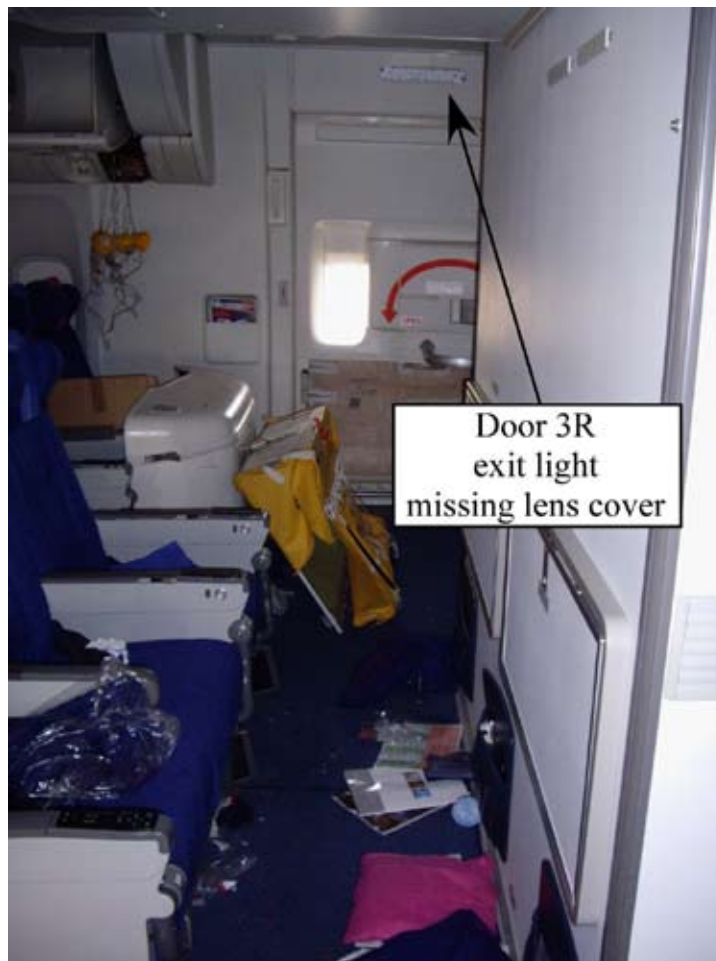
Figure 38

The exit signs light lenses were found to have detached from Door 3L and 3R (Figure 38) and it was evident that any misalignment of the plastic door mouldings resulted in difficulty in engaging all four of the mounting clips.

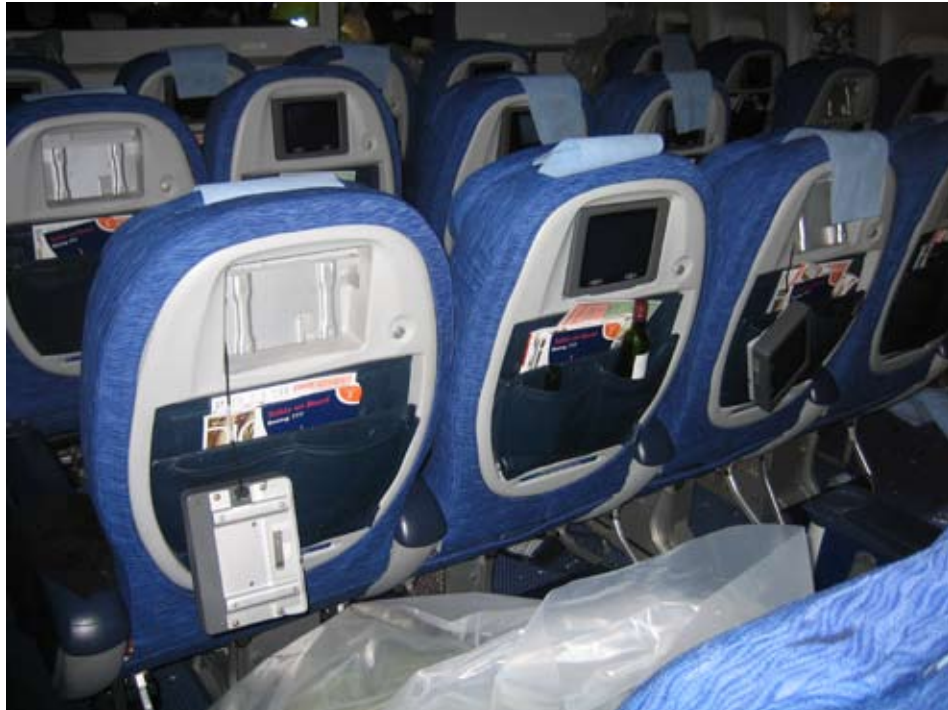
Figure 39

Further examination revealed that by exerting a downward force by hand, it was possible to detach one of the monitors which otherwise appeared to be correctly located. The spring clip attachments were found to be loose, allowing movement of the clip and preventing correct engagement in the detent.

Business Economy section showing video monitors detached from the seat backs

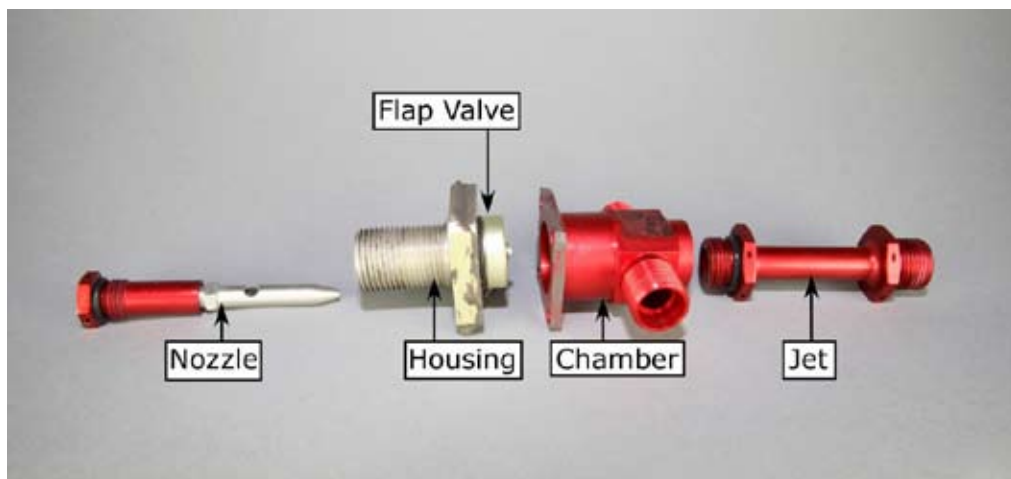
Figure 44

When the nozzle from the right main scavenge jet pump was removed from its housing half a teaspoon of a 'jelly-like' substance, later identified in a laboratory as "water", was found in the housing. It is not known if this water was originally lodged in the nozzle and was pulled through the flap valve into the housing, or whether the water had been introduced into the housing during a previous maintenance activity. The water was tested for microbiological contamination and the quantity of contamination was assessed as negligible.

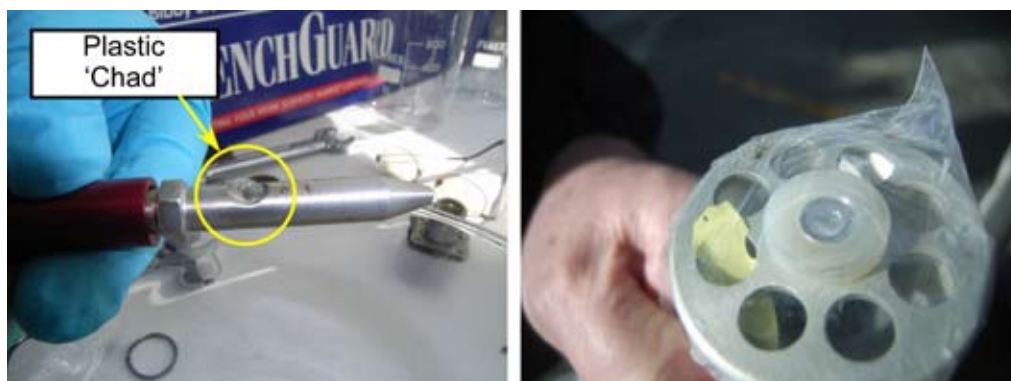
Figure 45

A 6 mm plastic disc (chad) was found in the chamber of the right main scavenge jet pump, which was large enough to block one of the ports in the nozzle, Figure 45. A flake of paint was found trapped in the pipe between the scavenge inlet and the chamber (Figure 45). From a swab taken from the inside of the chamber, it was established that there was a moderate amount of microbiological contamination on the internal surfaces of the chamber.
