SCAAI-1400/2011-EPWA-SP-LPC (rev.1)

## **Accident Description**

Status: **Preliminary Report (rev.1)**

Type: **Boeing B-767-300**

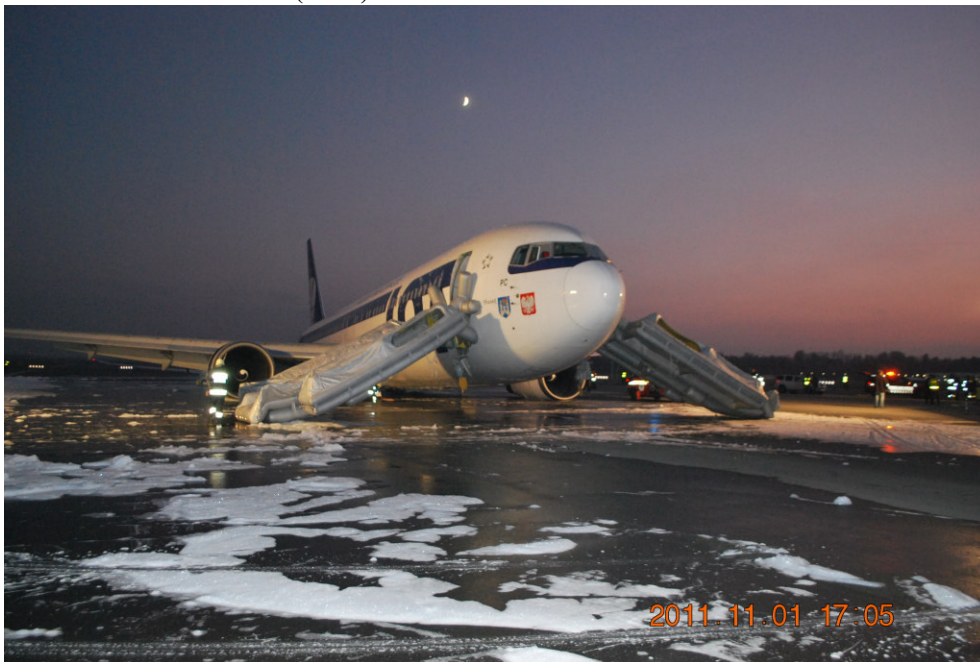
Photo1. General view of SP-LPC after emergency landing.

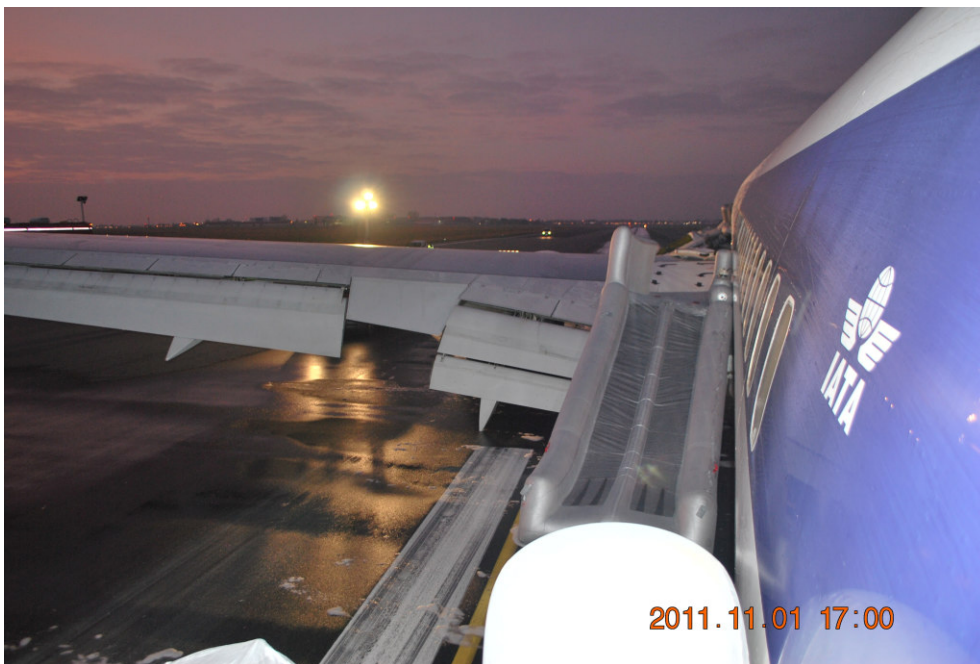
Photo 2. View on the left wing of the airplane from the rear main door.

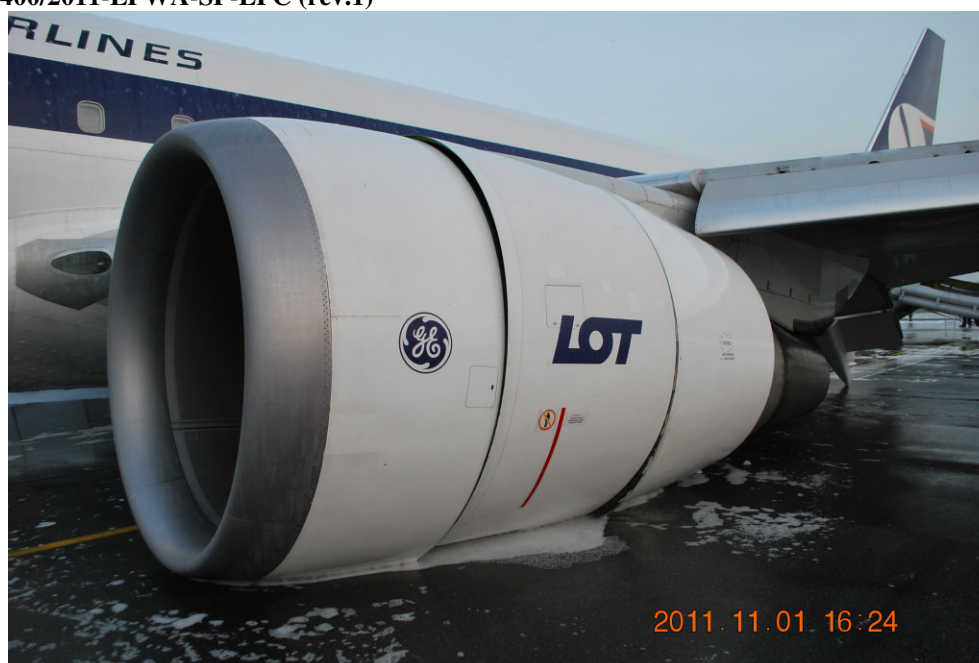
Photo 3. Left engine of SP-LPC airplane

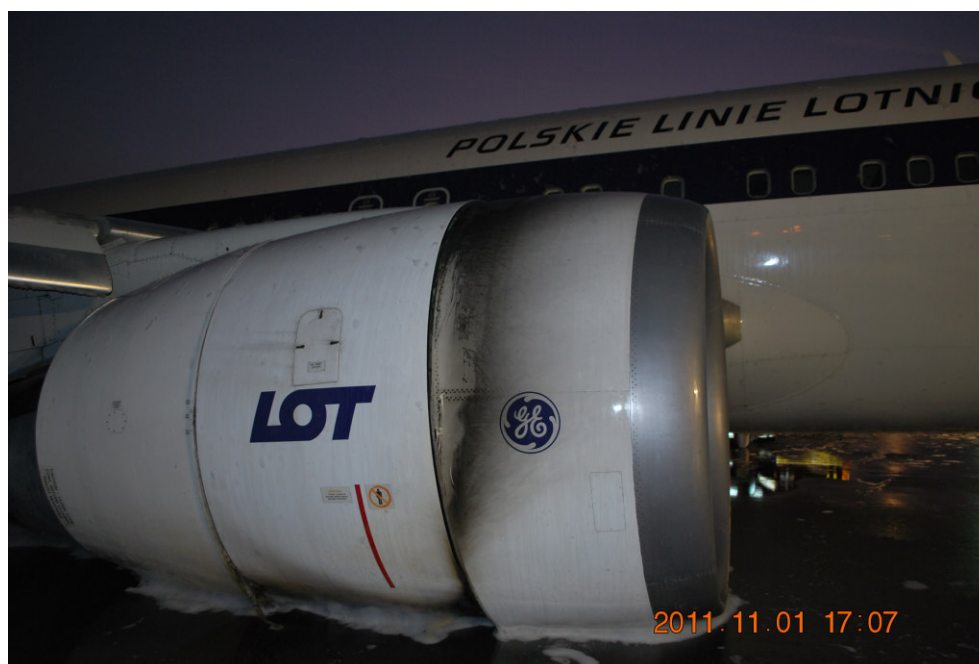
Photo 4. Right engine of SP-LPC airplane.

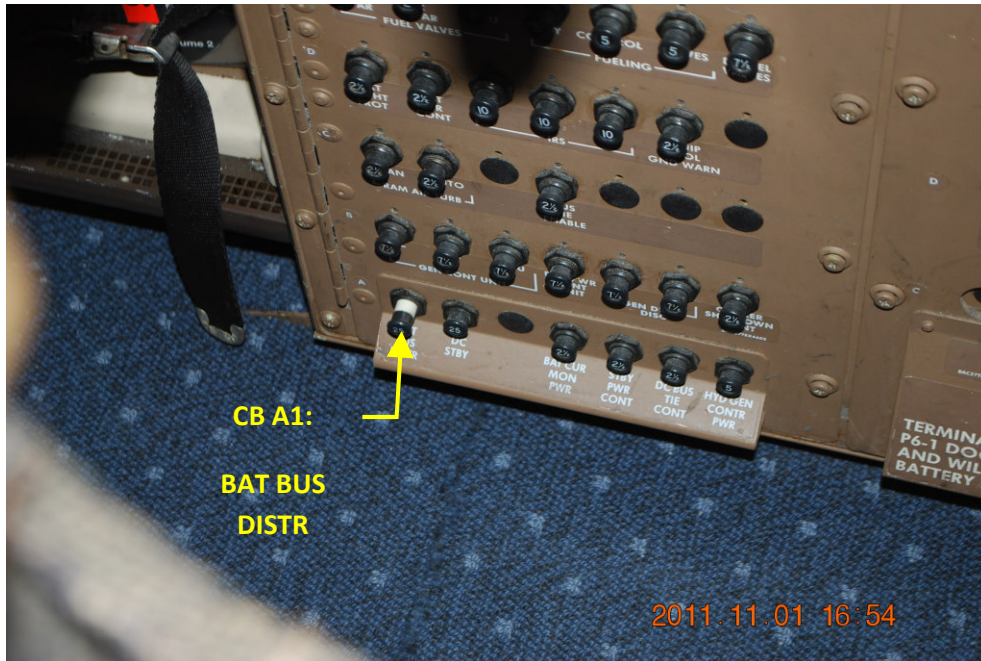
Members of the State Commission on Aircraft Accident Investigation arrived at the aerodrome about 15-20 minutes after the evacuation of passengers and crew. They carried out the initial inspection of the aircraft and found that in the cockpit, on P6 panel, the circuit breaker **C829 BAT BUS DISTR** (on A1 position) was in the position „Off”, while the circuit

breaker **C4248 LANDING GEAR - ALTN EXT MOTOR** (on F6 position) was in the position „On”. Records of on-board recorders (CVR - Cockpit Voice Recorder, FDR - Flight Data Recorder and QAR - Quick Access Recorder) were protected and photographic documentation was made.

Photo 5. P6-1 circuit breakers panel in the cockpit.

The circuit breaker C829 (BAT BUS DISTR) indicated on Photo 5 protects several airplane systems including the alternate landing gear extension system. The „Off” position of the circuit breaker was not recorded or indicated by the airplane systems (FDR - Flight Data Recorder and EICAS - Engine Indications and Crew Alerting System).

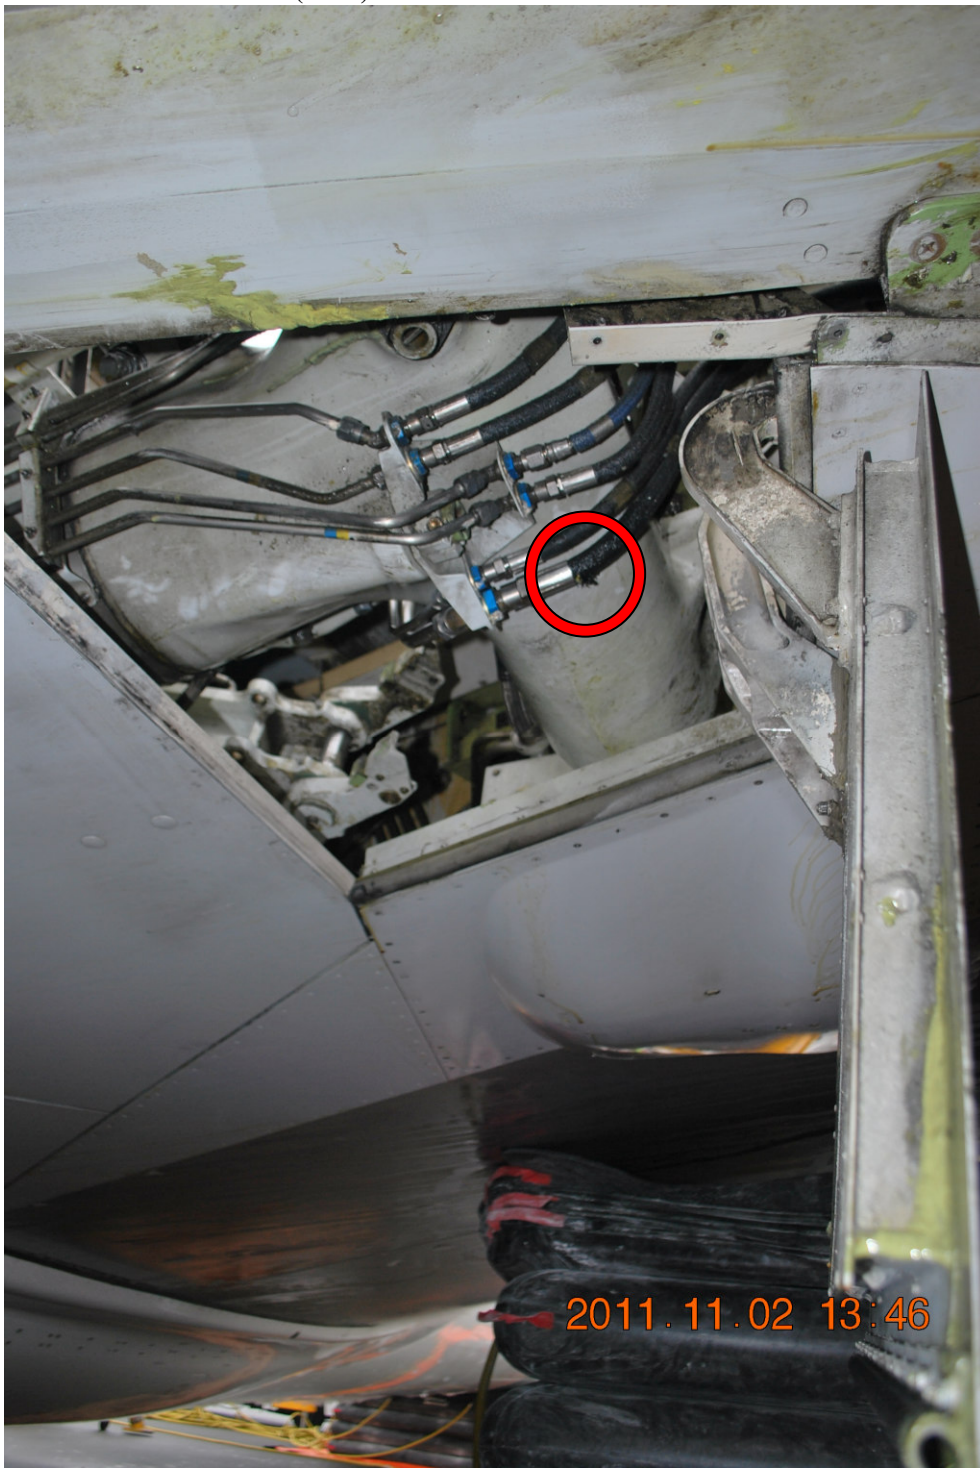
The electrical systems connected with C829 (A1) „BAT BUS DISTR” circuit breaker  
On 2 November the place of hydraulic fluid leakage was identified (see Photo 7 and 8).

Photo 7. View of the hydraulic hoses of the right main landing gear of SP-LPC airplane

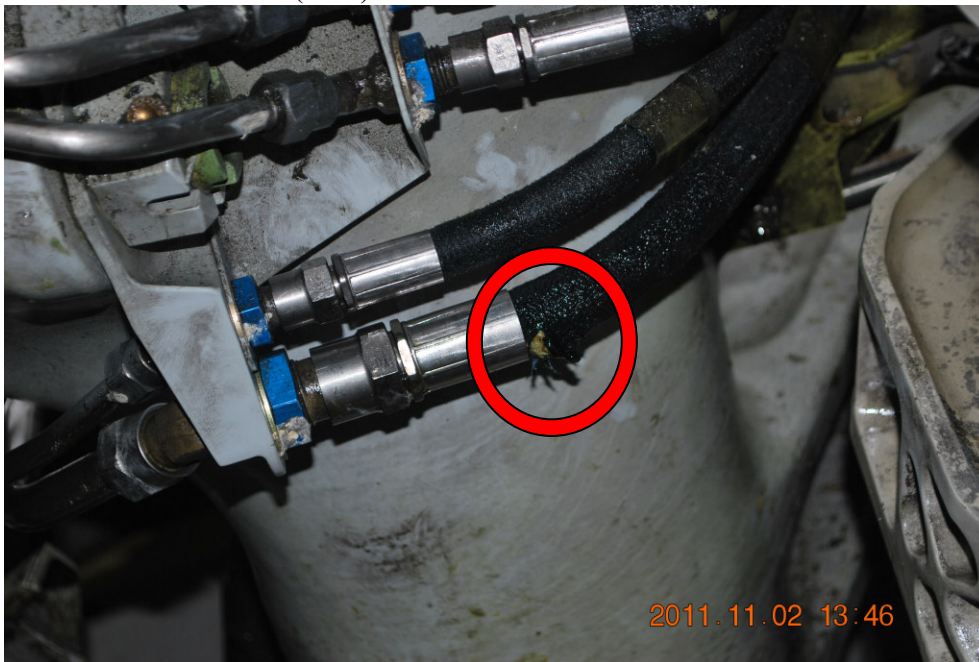
Photo 8. Damaged hydraulic hose of the right main landing gear of SP-LPC airplane.

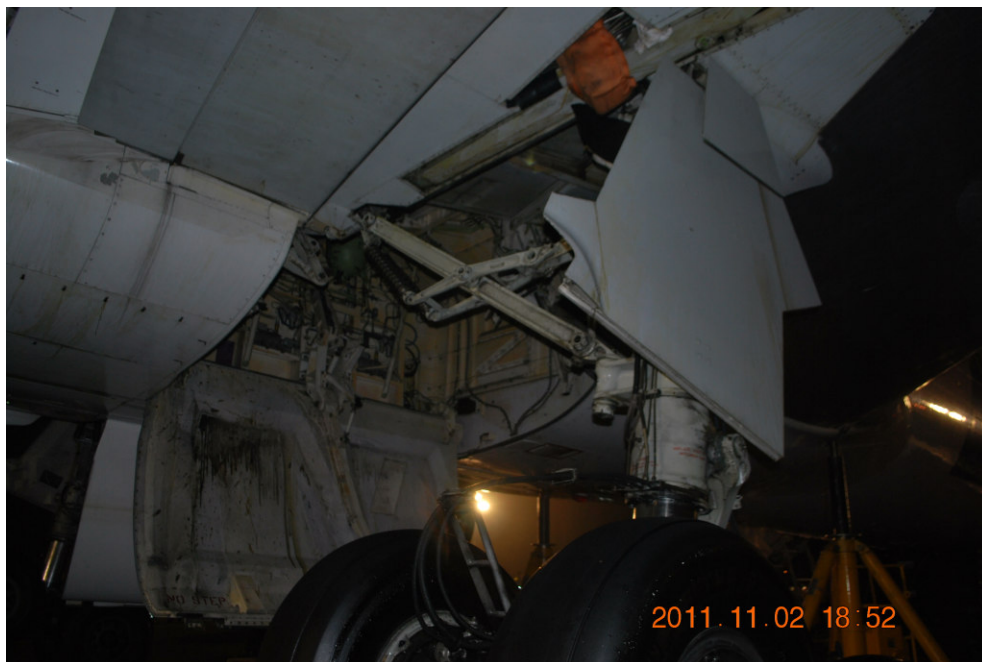
After lifting the aircraft from the runway, in agreement with this operation manager, a test of the landing gear extension with the alternate landing gear extension system was carried out. After connecting the ground power unit, setting C829 (A1) BAT BUS DISTR circuit breaker in the position „On” and activation of the alternate landing gear extension system, the landing gear was extended. The aircraft was towed to the operator's technical base.

Photo 11. Extended right main landing gear after lifting SP-LPC airplane.

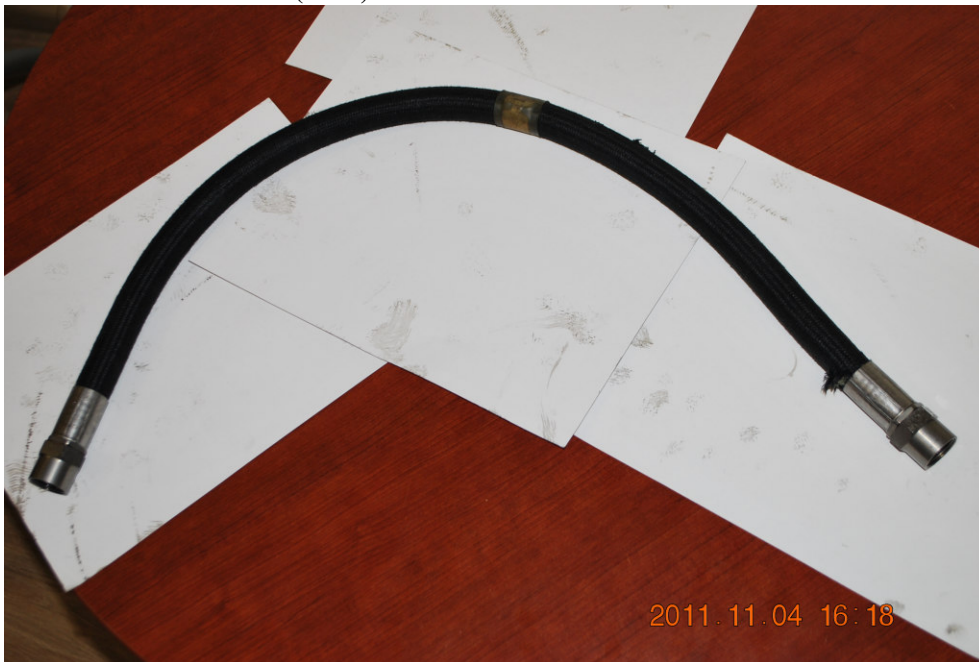
On 4 November members of SCAAI Investigating Team participated in disassembly of the damaged hose of the hydraulic system „C” (central) and secured the hose to carry out tests. The hydraulic hose together with photographic documentation was sent to the laboratory of National Transportation Safety Board (NTSB).

Photo13. Damaged hydraulic hose of the landing gear extension system of SP-LPC airplane.

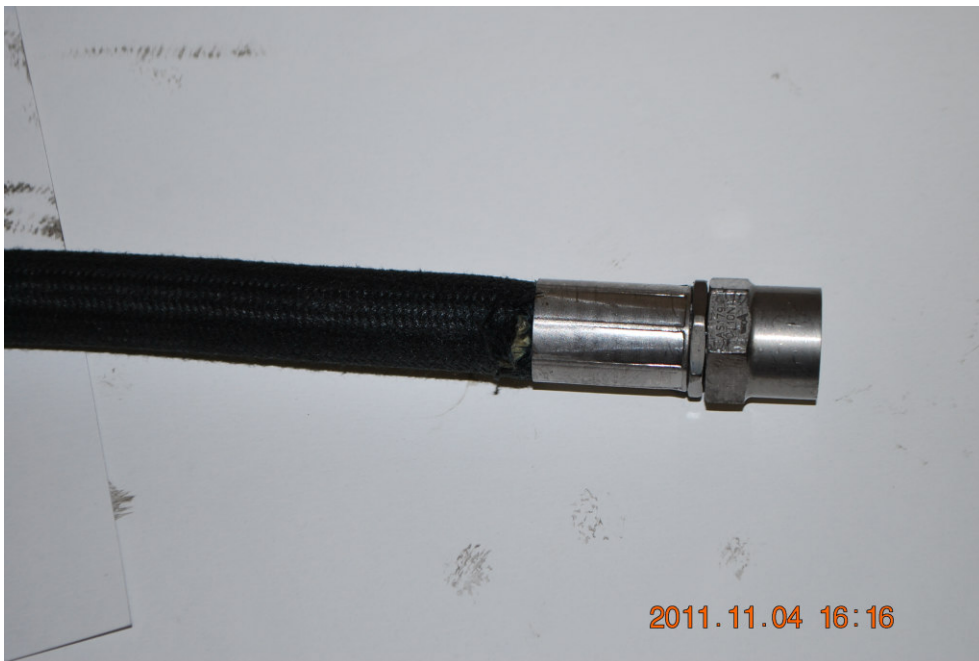
Photo14. Damage to the hydraulic hose of the landing gear extension system of SP-LPC airplane.

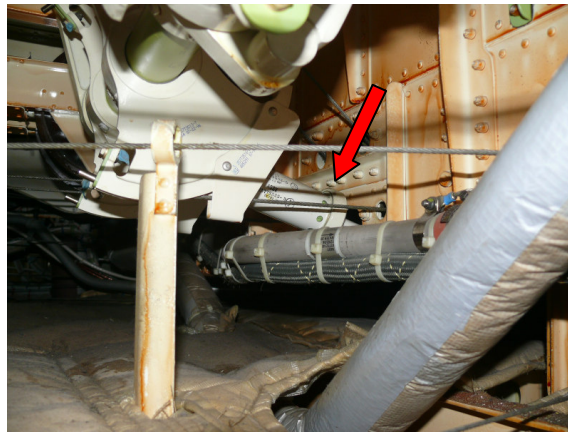
Visual inspection of individual elements of the alternative system of landing gear extension was made. Condition of all load limiters (indicators) of this system did not raise any objections (NLG / MLG LOAD limiters).

Photo 15. Load Limiter of the nose alternate landing gear extension system.

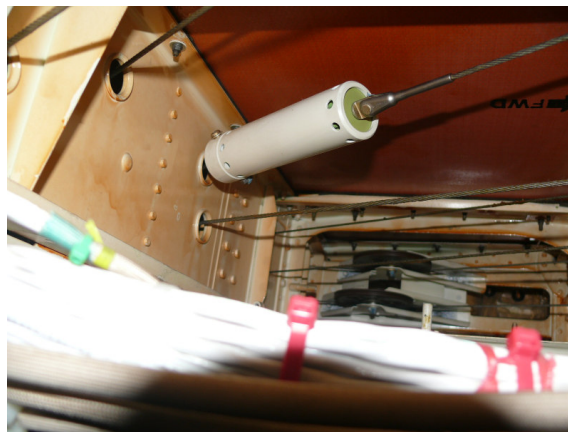
Photo 16. Load Limiter of the main left alternate landing gear extension system.

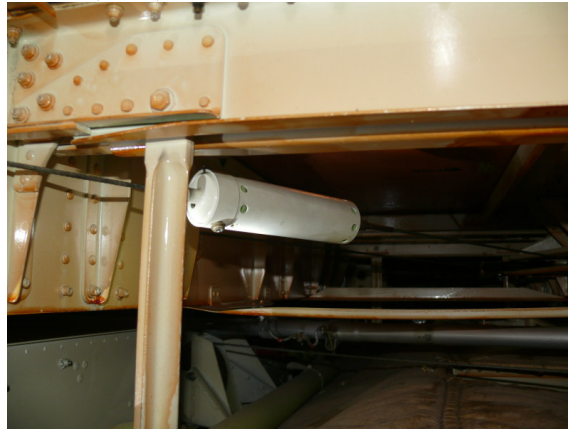
Photo 17. Load Limiter of the main right alternate landing gear extension system.

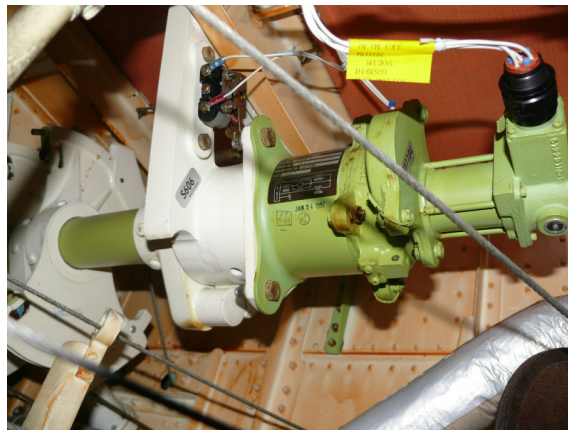
Photo 18. Electric motor of alternate landing gear extension system.

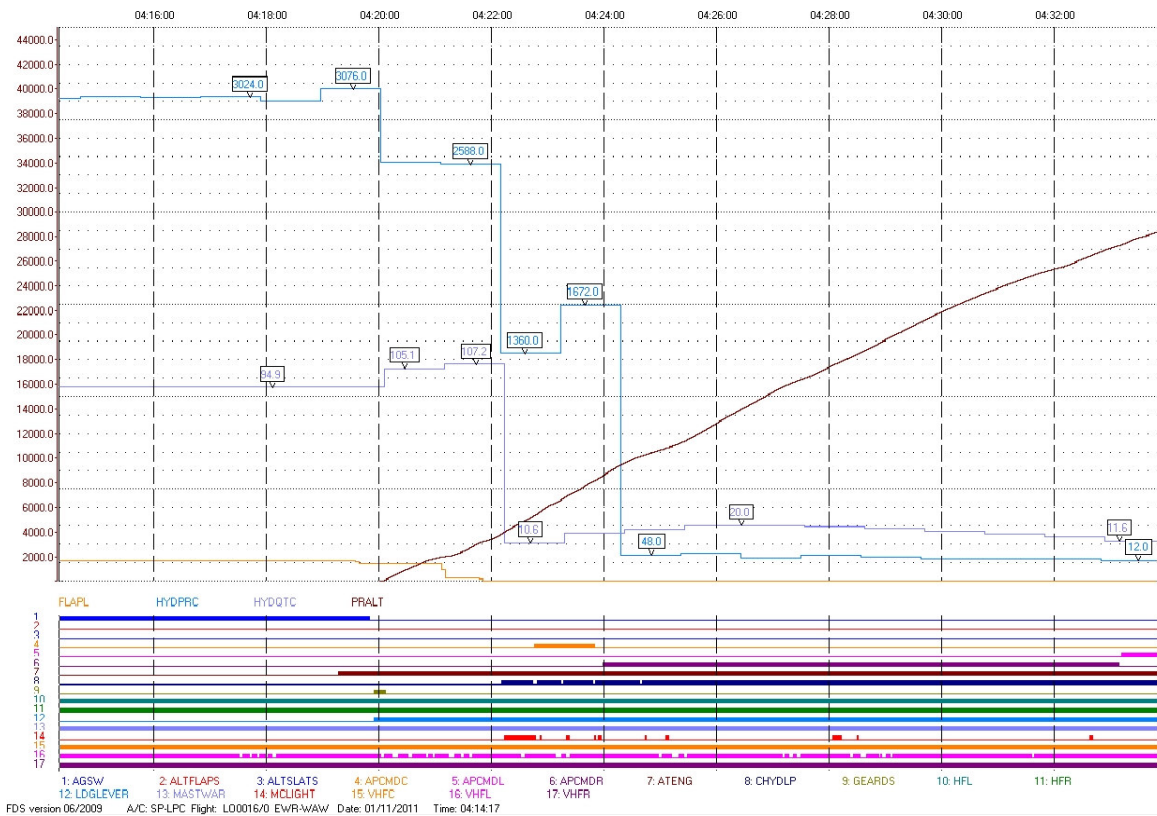
Pressure drop in SP-LPC central hydraulic system after take off – based on FDR recording
