AIRCRAFT ACCIDENT REPORT 1/2010

Air Accidents Investigation Branch

**Report on the accident to
Boeing 777-236ER, G-YMMM,
at London Heathrow Airport
on 17 January 2008**

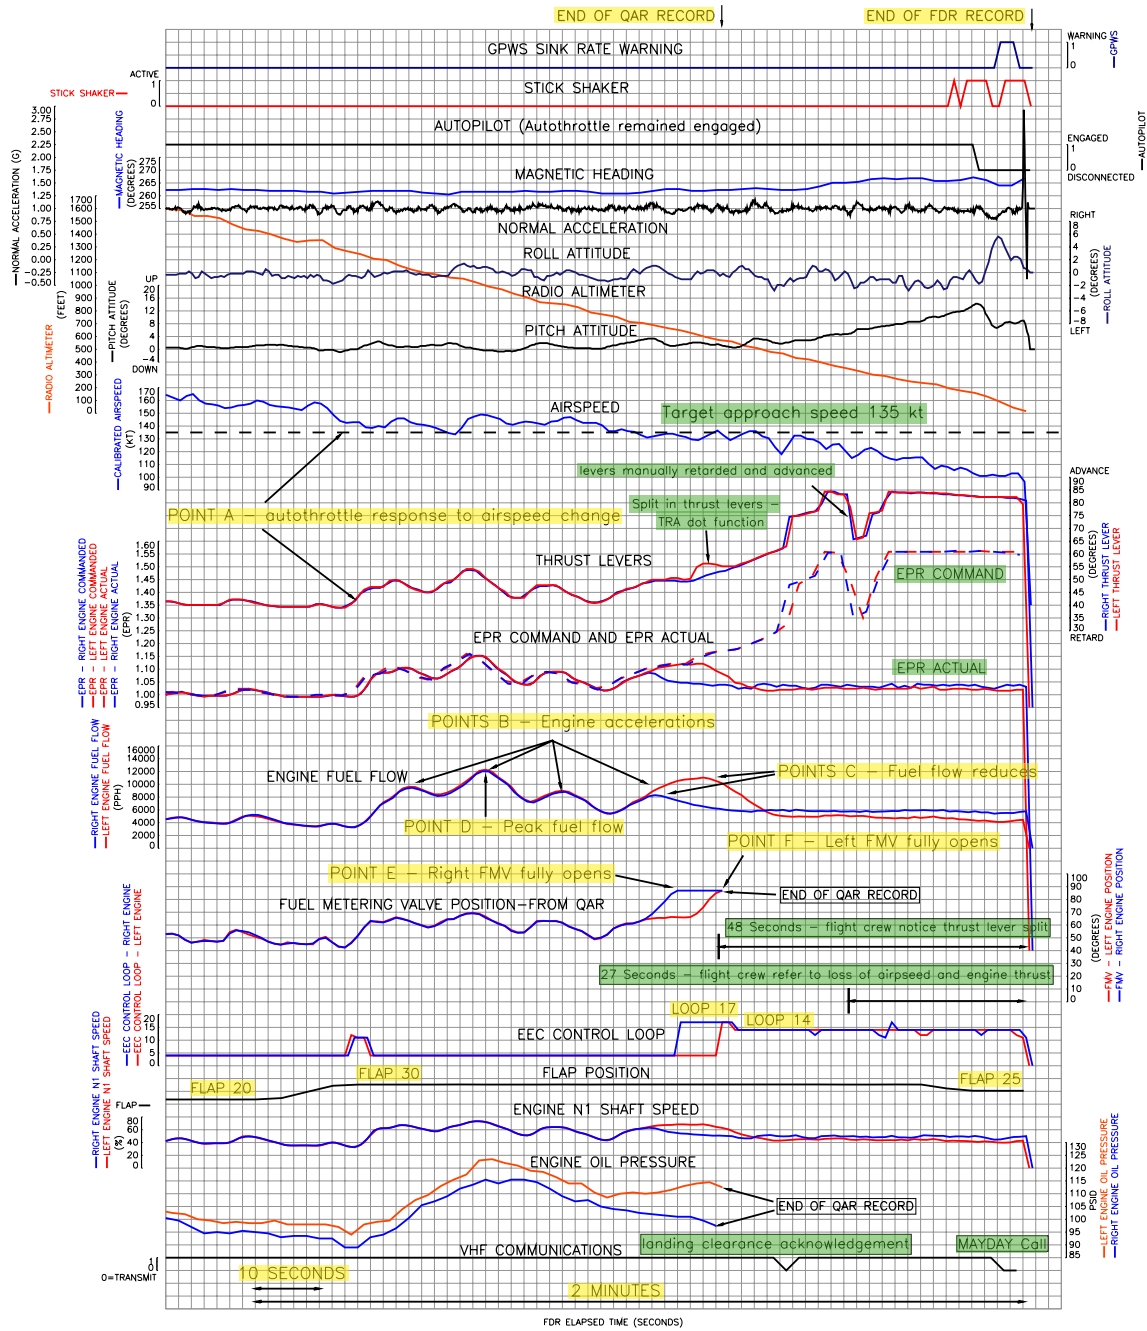
Figure 20

As the flaps reached the 30° position the airspeed had reduced to the target approach speed of 135 kt and the autothrottle commanded additional thrust to stabilise the airspeed (Figure 20, Point A). In response to variations in the wind velocity and associated airspeed changes, there followed a series of four, almost cyclic, thrust commands by the autothrottle (Figure 20, Point B). It was during the fourth acceleration, and as additional thrust was being commanded, that the right engine, followed some seven seconds later by the left engine, experienced a reduction in fuel flow (Figure 20, Point C). The right engine fuel flow reduction occurred at a height of about 720 ft and the left engine at about 620 ft. Just prior to the reduction in right engine fuel flow, about 2.5 nm from the runway, the flight crew were visual with the runway and the co-pilot became pilot flying (Figure 21).

Of the four thrust commands it was the second that resulted in the highest delivery of fuel flow, reaching a peak of 12,288 pph for the left engine and 12,032 pph for the right (Figure 20, Point D). These peaks occurred about 26 seconds prior to the reduction in fuel flow to the right engine. Peak fuel flows during the first and third thrust commands were lower, at about 9,500 pph and 9,000 pph respectively.

During the fourth thrust increase, the right engine fuel flow had increased to 8,300 pph before gradually reducing. The recorded EPR then started to diverge from the commanded EPR and the right engine FMV opened fully (Figure 20, Point E). Some seven seconds later, the left engine fuel flow, which had increased to 11,056 pph, also started to reduce and the left engine FMV also moved to its fully open position (Figure 20, Point F). The QAR record ended shortly after.

The data was examined with respect to oil pressure. This showed that both the left and right engines' oil pressure generally follow each other until the start of the final acceleration, which resulted in first the right and then the left engines rolling back. The left engine oil pressure rose, as expected, as the engine accelerated: the right engine pressure, however, started to decrease, even though the engine was also accelerating prior to its rollback. Whilst, this observation, on the right engine, was based on only a few data points, it can be inferred that this was due to an oil temperature increase at, or close to, the start of the final acceleration. However, the loss of QAR data so close to the left engine rollback meant that it was not possible to draw a similar conclusion for the left engine. (Figure 20)

Final minutes of approach

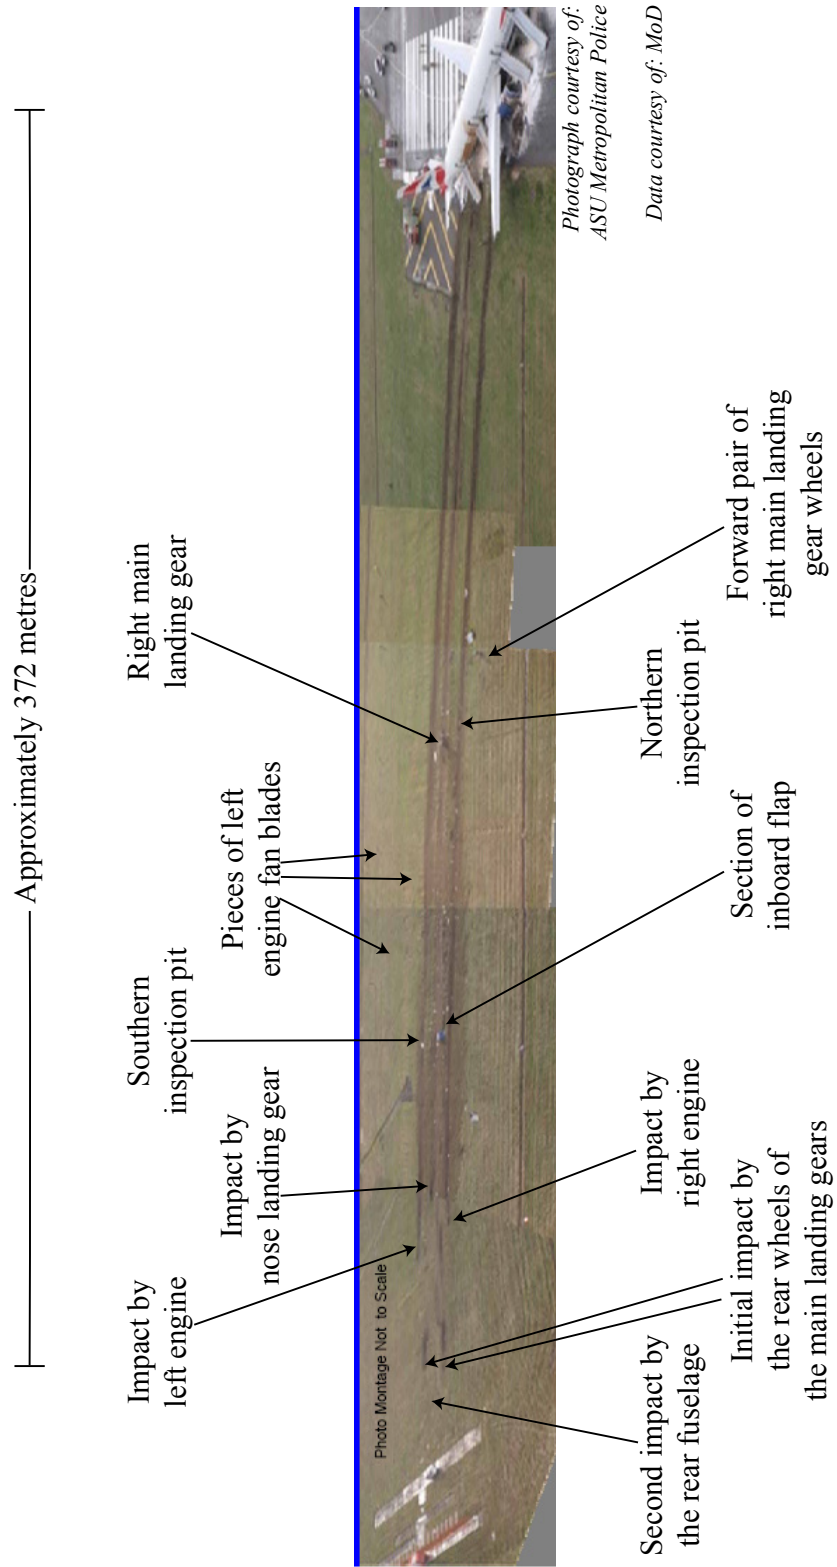
Also shown in Figure 23 is the final position of the main section of right MLG and the front section of the truck beam, with its two wheels.

This caused damage to the lower part of the engine and assisted the deviation of the aircraft's ground slide to the right.

The aircraft came to rest on the tarmac area just to the north of the threshold of Runway 27L, approximately 372 m from the first impact point.

Ground impact marks and wreckage trail

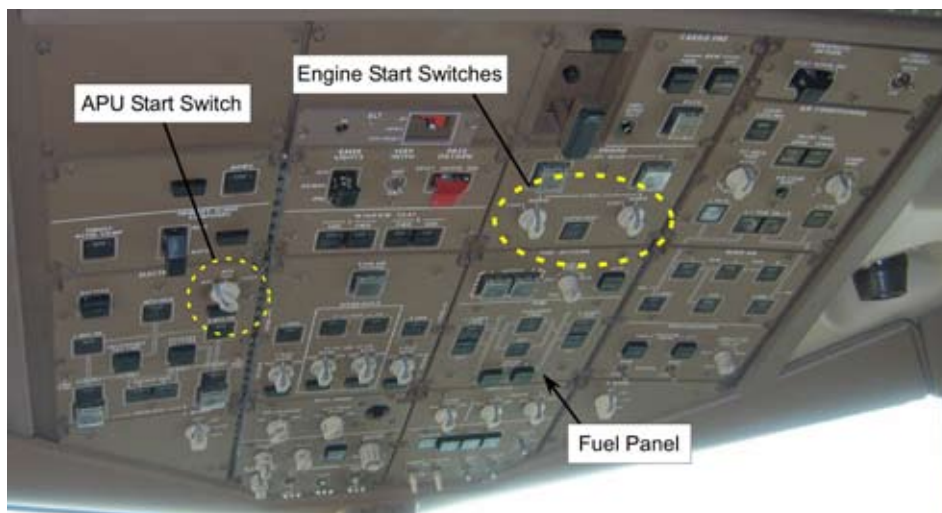
Figure 24

Engine thrust levers - Both engine thrust levers were in the full thrust position.

Flaps - FLAP 25 selected.

Overhead panel shortly after the accident

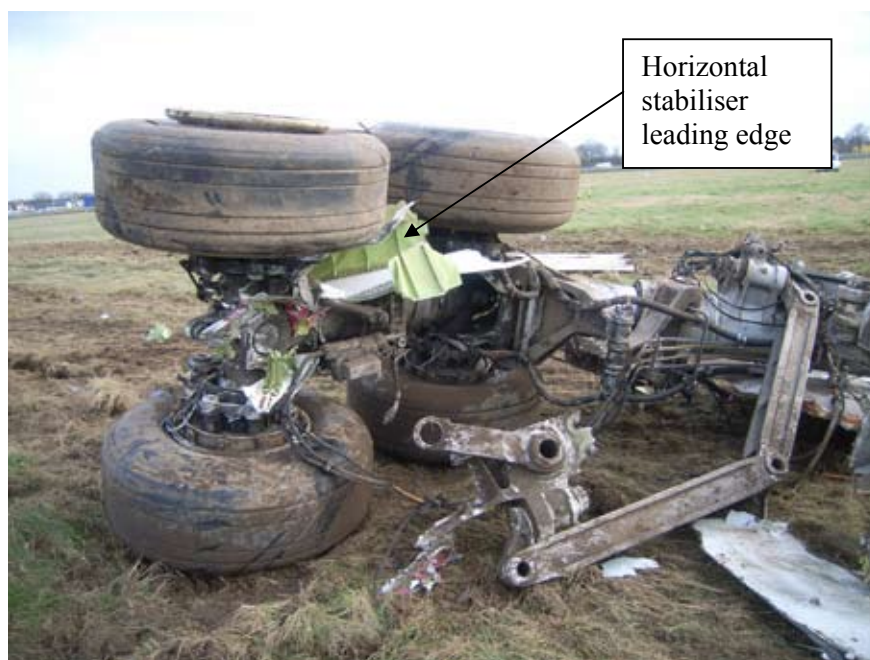
Figure 27

Right Main Landing Gear with embedded portion of right horizontal stabiliser leading edge

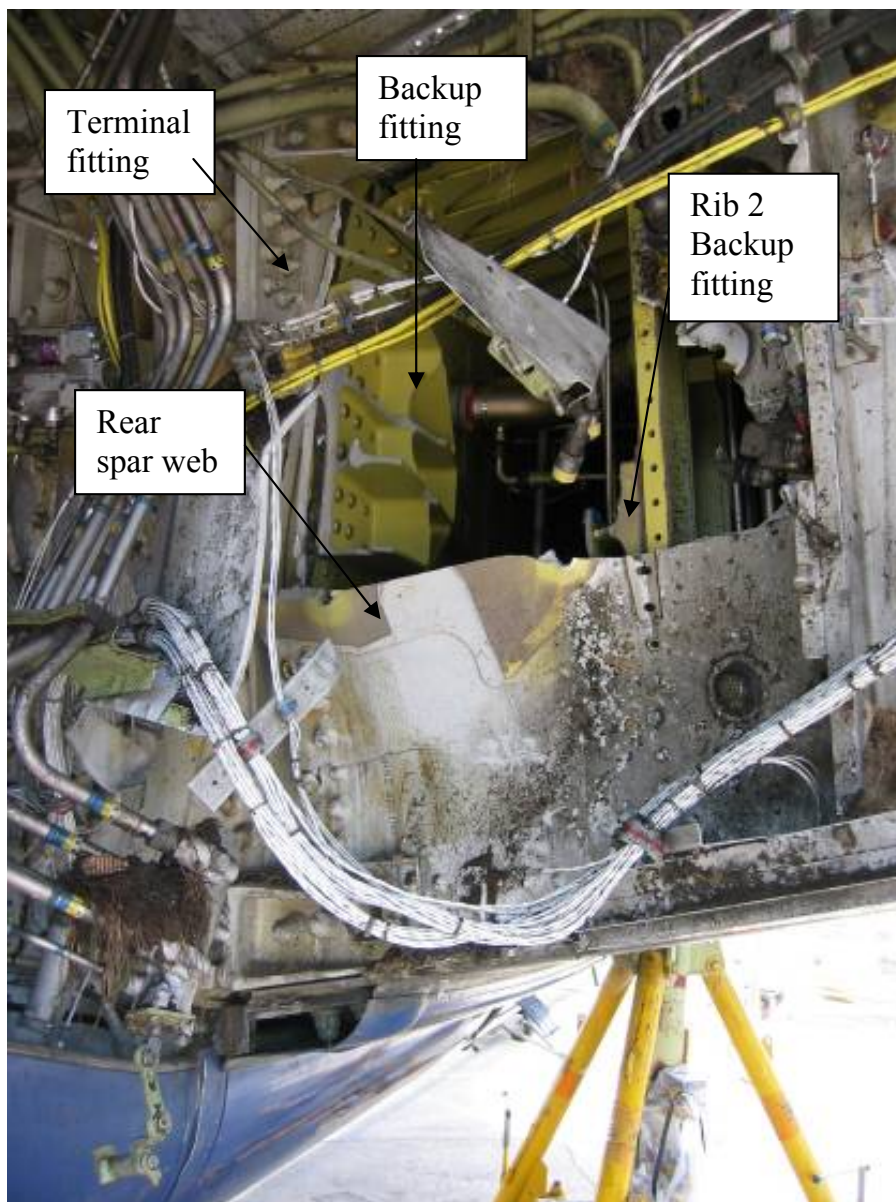
Figure 28

Right rear spar showing missing drag brace attachment point and centre fuel tank structure

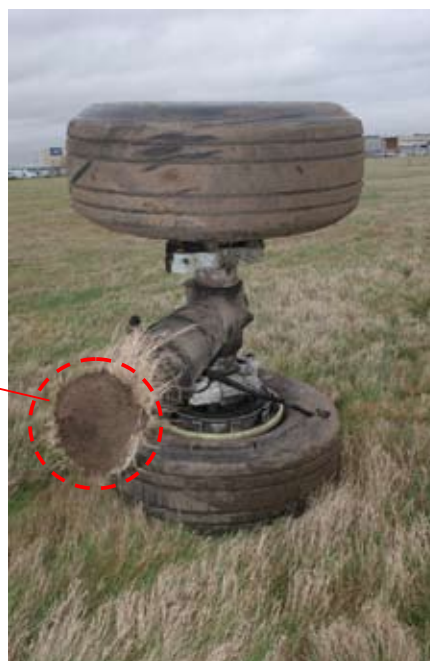
Figure 31

Forward portion of truck beam and two wheels

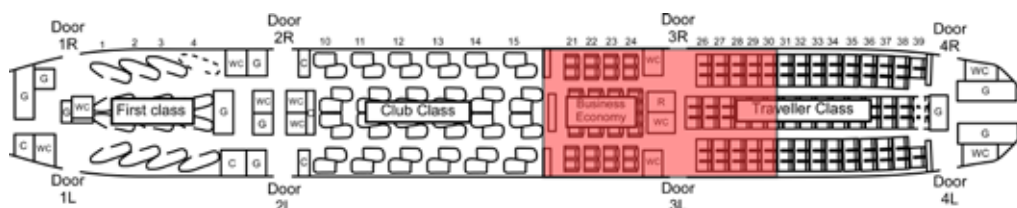
Figure 35

There were significant amounts of glass debris in the forward area of the Traveller cabin section, which was more extensive on the left side of the cabin in the region of Door 3L (Figures 35 to 37). The glass debris extended as far forward as Door 2L and 2R, and as far aft as seat row 31, with highest concentrations in the areas between rows 21 and 29.

Cabin layout showing location of glass debris

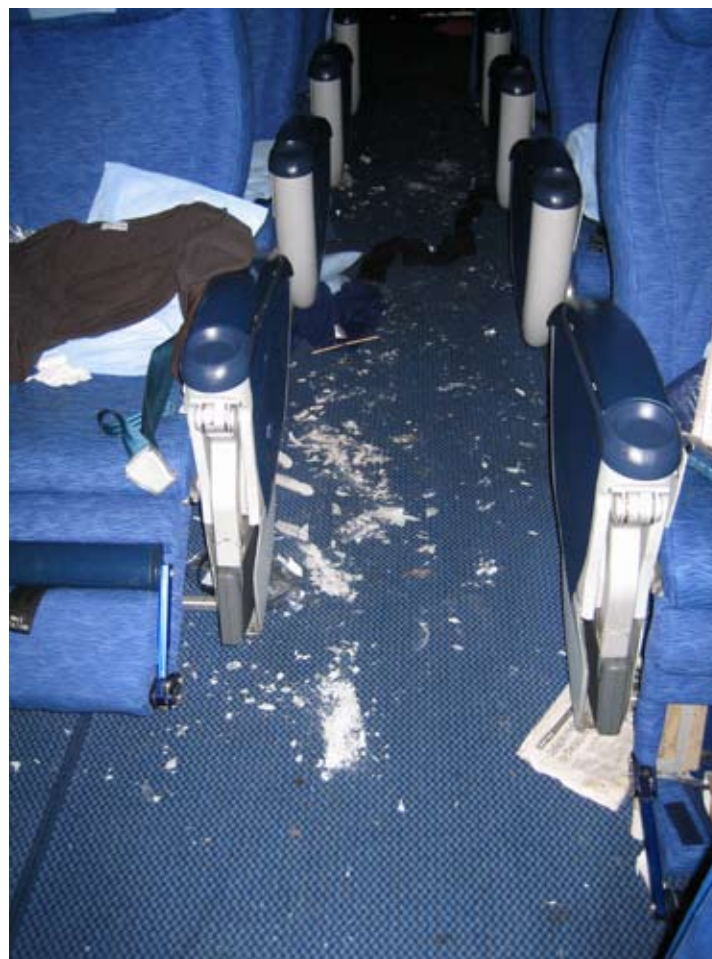
Figure 37

Debris on the floor from fluorescent tubes in area of Door 3L

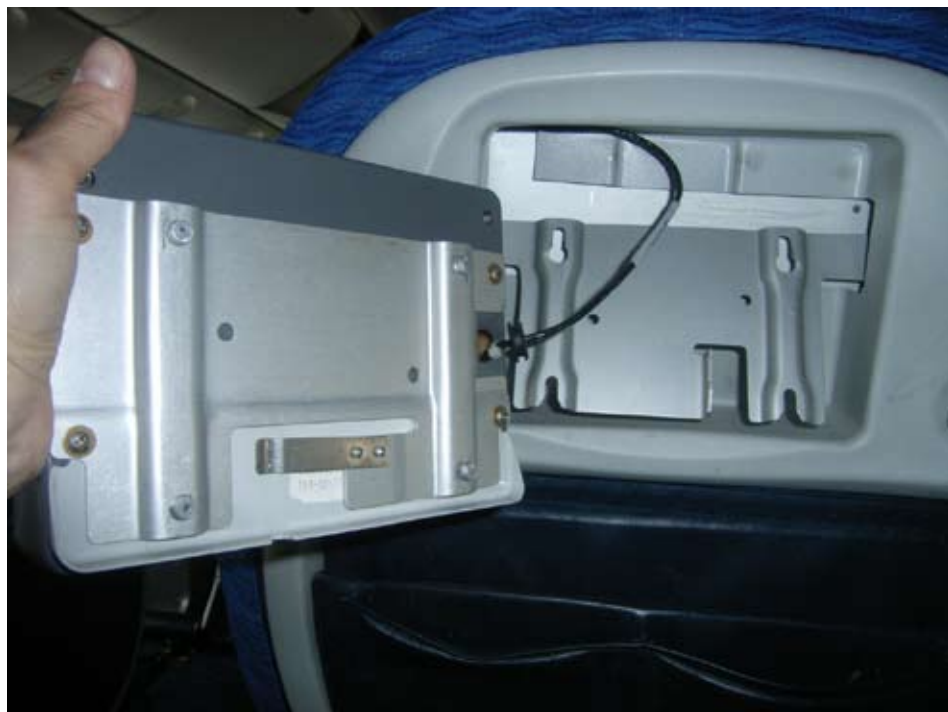
Figure 40

In the Business Economy section, nine of the 32 seat back video monitors had separated; of these, eight remained suspended by their electrical harness but one had separated completely and was found on the cabin floor (Figure 39).

Video monitor attachment fittings

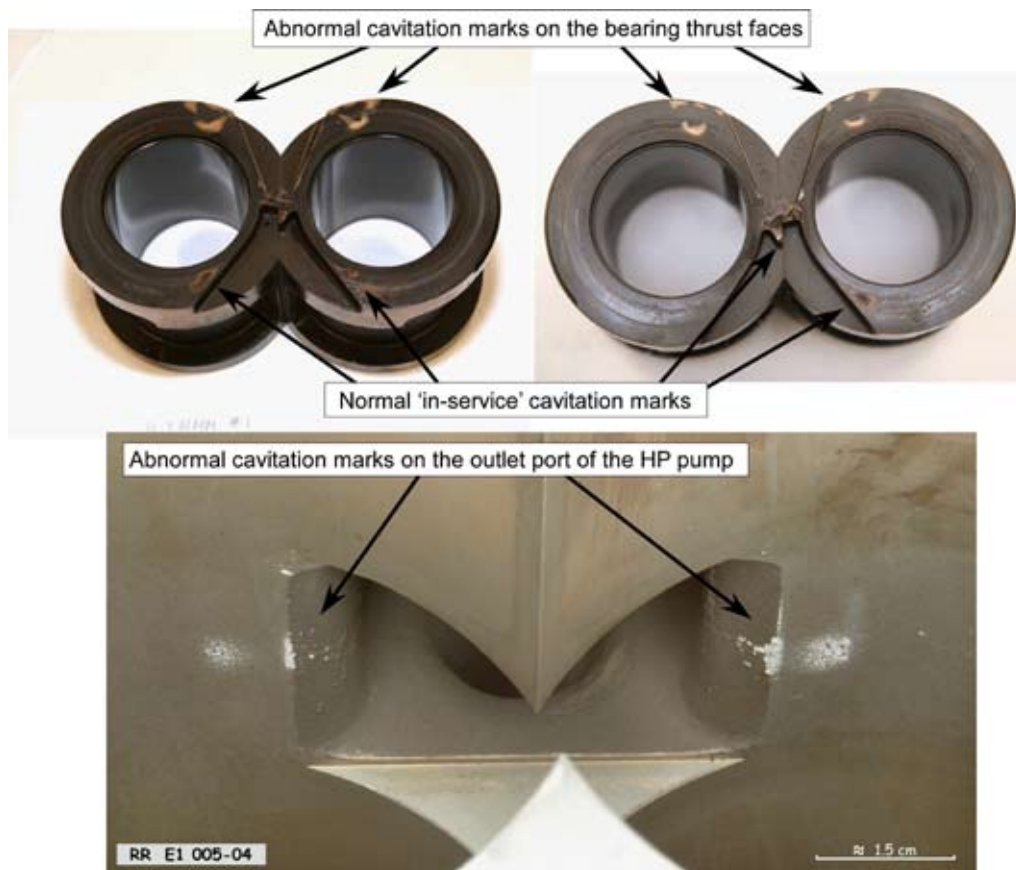
Figure 41

Strip of the HP gear pump did not reveal any mechanical discrepancies other than some unusual marks on the delivery sides of both pumps which the manufacturer described as being indicative of 'cavitation' (Figure 41). The marks comprised slight, but distinct, erosion of the dry film lubricant on the bearings and also of the outlet ports: they appeared fresh and bright.

Advice from the pump manufacturer was that these marks, at this location, were highly unusual. However, local cavitation erosion was to be expected at various known positions, mainly associated with the inlet side of the pump; the marks were hardly ever seen at the outlet ports. A series of tests had been carried out originally to certify the pump. Part of the tests involved running a pump at very low inlet pressures for several minutes. When the unit was stripped, marks were present which were almost identical to those which had been found on the pumps from G-YMMM. (Appendix E 'Explanation of Cavitation'.)

Apart from the marks, which would have had no effect on pump operation, no other abnormalities were found in either MEP from G-YMMM.

Cavitation markings on the HP pumps from G-YMMM

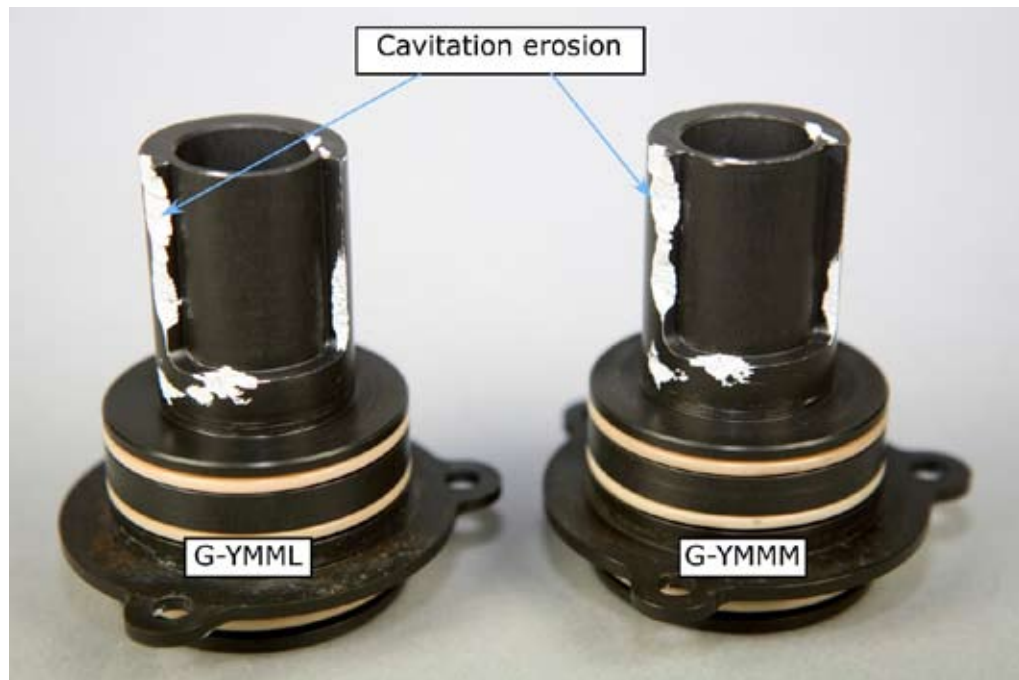
Figure 42

Inspection of the boost pumps revealed cavitation erosion on the re-prime pump stator and discoloration of the surface treatment on the re-prime impeller, which was assessed to have been caused by cavitation erosion. A comparison of this damage was carried out against boost pumps removed from another of the operator's aircraft, G-YMML (Figure 42). All the boost pumps from both aircraft, which had a similar service history, displayed the same cavitation damage to the re-prime stator and impeller. The pump manufacturer demonstrated that this type of damage was normal for pumps of this age.

Cavitation wear marks on the re-prime pump stator

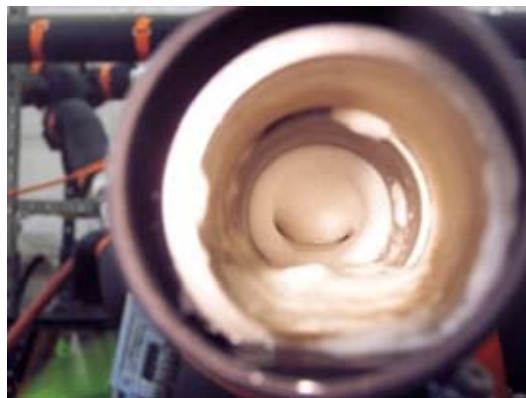
Figure 50

The only occasion when it appeared that there might be a sufficient quantity of ice to block a pipe occurred when approx 6 litres of water had been injected into the boost pump inlet over a period of 7 hours. During this period the flow rate was maintained at 6,000 pph and the water content varied between 100 and 150 ppm. On dismantling the system a large ball of soft ice was found just down stream of the spar valve on a coupling that is not used on the aircraft (Figure 50). Despite the presence of the ice, no pressure drop was detected across this section of tube whilst the fuel was flowing at 6,000 pph.

Ball of soft ice found in pipework in the fuel test rig assembled from steel components that are not used on the Boeing 777

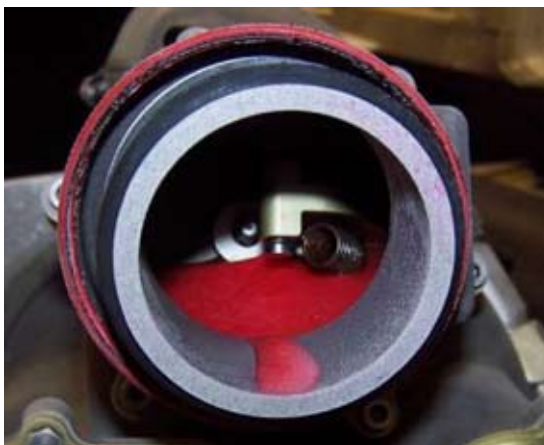
Figure 51

To explore this theory, a number of tests were carried out using dyed water that had been frozen in a check valve housing (Figure 51). In one test, compressed air was applied to the valve which started to open when the pressure was approximately 3 to 4 psi. On another test, with the housing fitted to the rig, it was possible to achieve a flow of 28,000 pph. At the end of these tests the ice chip was still located in the housing.

Dyed ice in check valve housing

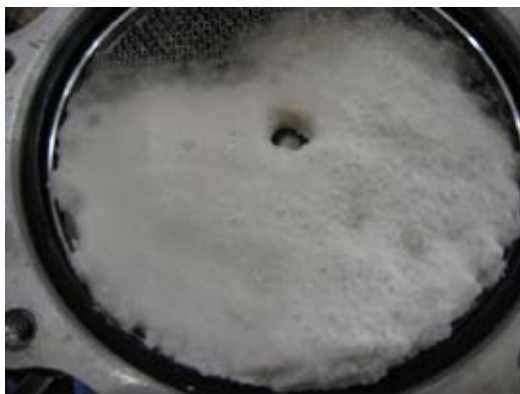
Figure 52

During the 'snowball' tests, with the fuel flow set at 6,000 pph, it took approximately 40 seconds for the water introduced at the boost pump inlet to reach the face of the FOHE. As the water flowed through the fuel system it turned into ice crystals and under certain conditions these crystals would collect on the face of the FOHE, restricting the fuel flow (Figure 52). However, during

all of the testing the fuel flow never fell below that required by an engine at flight idle. Moreover, the restriction could always be cleared by reducing the fuel flow to idle, which resulted in a change in the equilibrium between the cold fuel and hot oil in the heat exchanger, such that the ice melted on the inlet face of the FOHE, sufficient to restore the demanded fuel flow.

Ice collected on the face of the FOHE

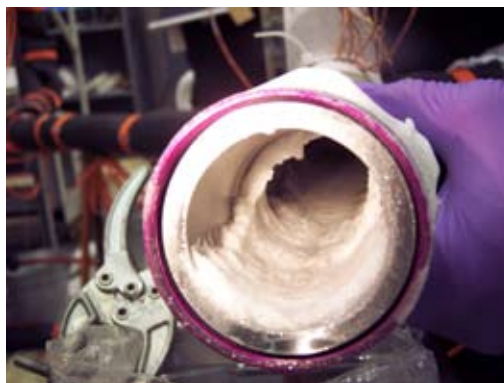
Figure 53

- The ice was soft and easy to move and there appeared to be no difference in the properties of the ice that accumulated at any of the cold test temperatures. However, in the test when the fuel temperature was cooled from -12°C to -33°C, the surface of the ice took on a 'pebbly' appearance.

Ice in the flexible hose located at the rear of the strut

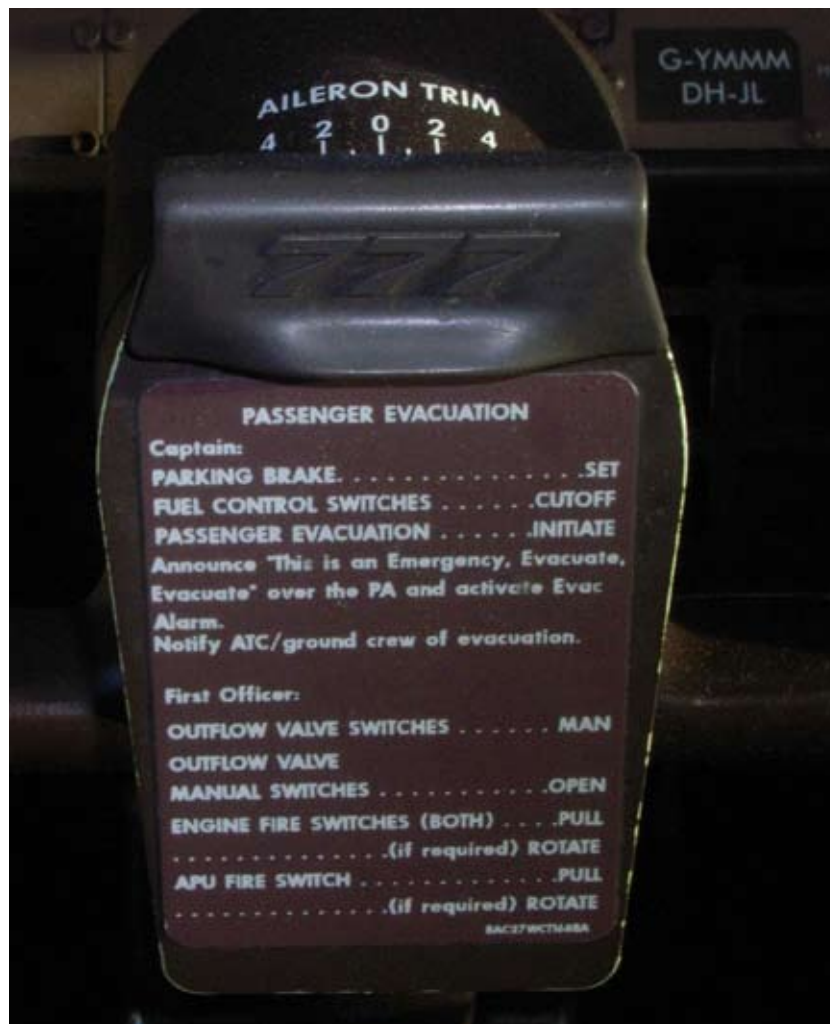
Figure 56

The operator's evacuation checklist, for which Boeing had raised no technical objection, required the commander ('*Captain*') to operate the fuel control switches whilst the co-pilot ('*First Officer*') operated the fire handles, this was in order to reduce the time required to action the checklist. These actions

were carried out independently, with no measure in place to ensure the correct sequencing. The evacuation drill was on a placard mounted on the face of the control column boss (Figure 56).

Evacuation check list on G-YMMM control column

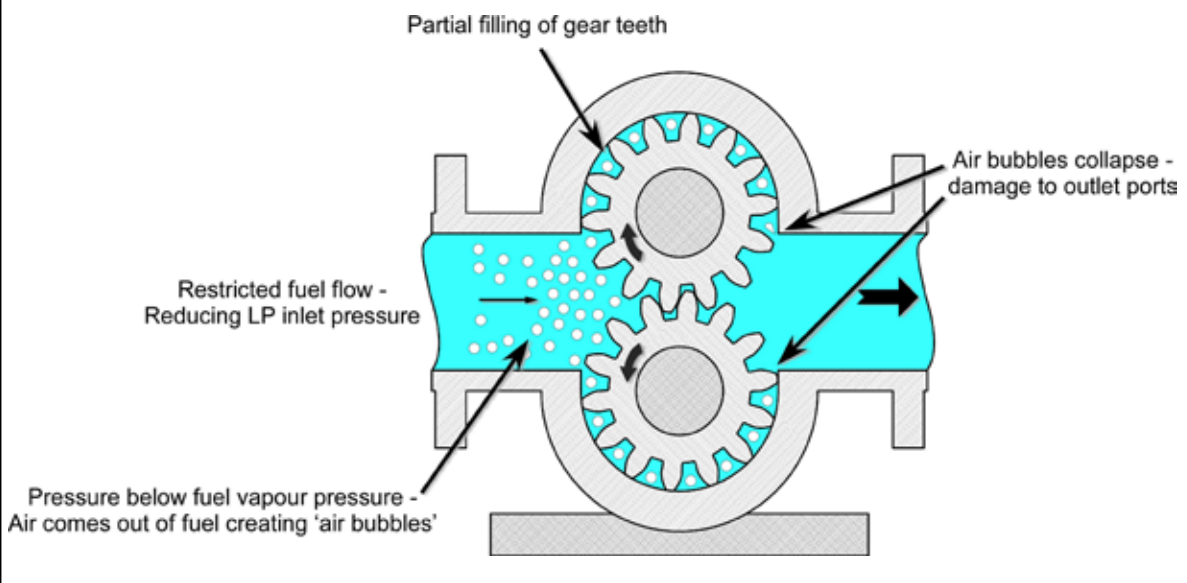
- Picture 4

Cavitation can occur with the presence of fuel vapour or air bubbles in the fluid and, given the low inlet pressure and high velocities, a certain amount of cavitation erosion is not unusual. The erosion is caused by the collapse of the bubbles which occurs violently and creates a shock wave of fluid. Striking a solid surface, the shock wave can cause progressive damage if it persists. In the case of the HP pumps fitted to G-YMMM, a degree of 'normal' cavitation damage is expected on the bearings where the teeth mesh and on the teeth themselves (Picture 4). The rate of erosion is a known quantity and does not affect operation of the pump within its overhaul life.

The inlet pressure to the pump should be maintained such that formation of air/vapour bubbles is minimised and, on most jet aircraft, this is achieved by the combination of aircraft booster and engine low pressure pumps. However, even if these are working correctly, a restriction in fuel flow upstream can result in the HP pump lowering its inlet pressure to the point at which a large quantity of air and vapour bubbles are formed. This gives rise to a mixture of fluid and gas bubbles filling the gear teeth. As these gear teeth open to the high pressure outlet port of the pump, the gas bubbles collapse and the high pressure fuel in the outlet port rapidly fills the available space. Both these actions result in shock waves being formed that cause damage to the outlet port and the delivery side of the bearing faces. This is the abnormal cavitation damage seen on both HP pumps from G-YMMM.

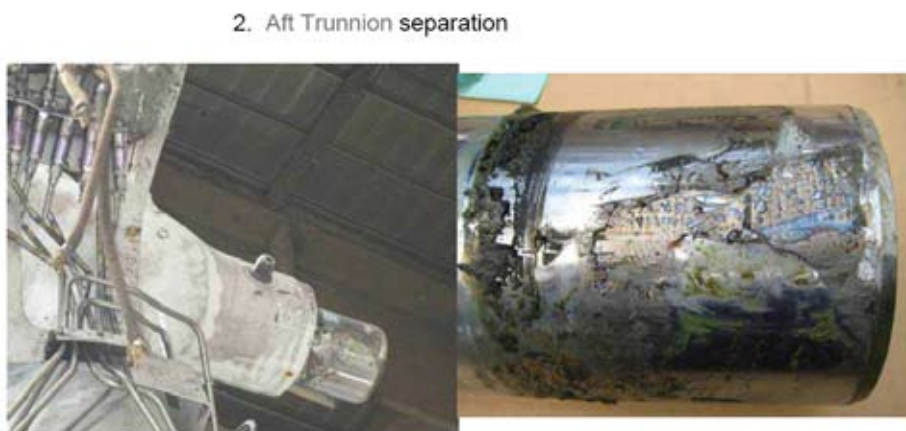
2. Aft trunnion separation

Note the piece of upper wing skin removed by the separation of the upper and lower housings. This impact had pried open the wing tank.

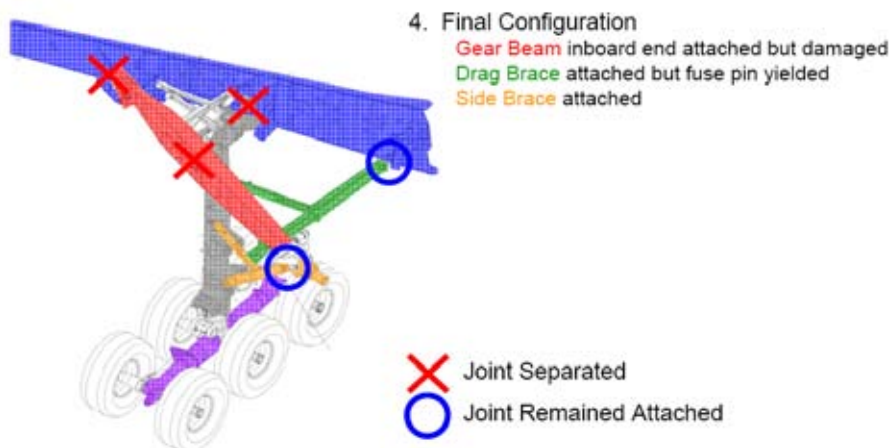
4. Final Configuration: Gear beam inboard end damaged but still attached, drag and side brace both folded but still attached.

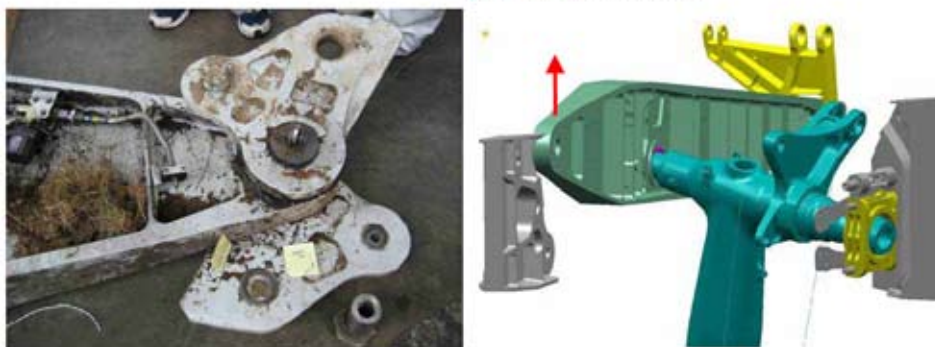
- 1. Initial impact: Gear beam outboard end fuse pins fail and gear beam forced upwards
- Side brace folded and gear beam forced inboard
- Gear beam rotated upwards and contacted the aft trunnion pin
- Forward trunnion lower housing (H block) fuse pins failed

1. Initial Impact
Gear Beam fused upwards

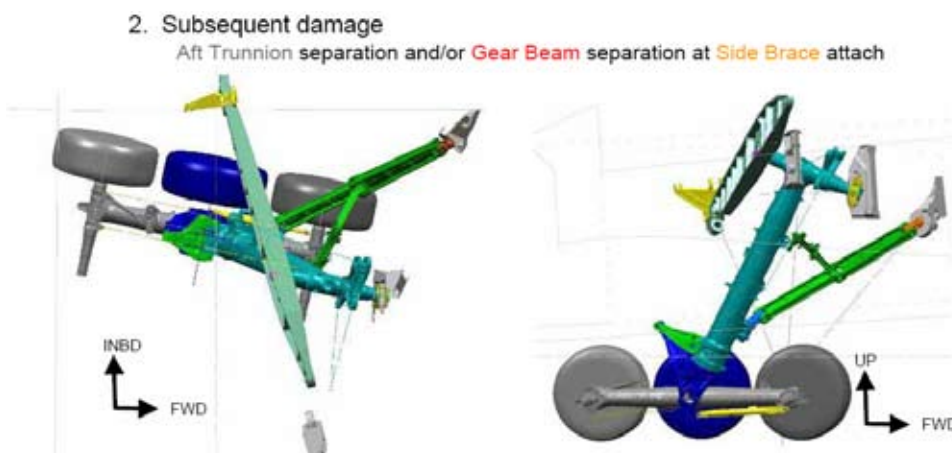
2. Subsequent motion: Forward trunnion levered aft and down

Aft trunnion separated and/or gear beam separated at side brace attachment

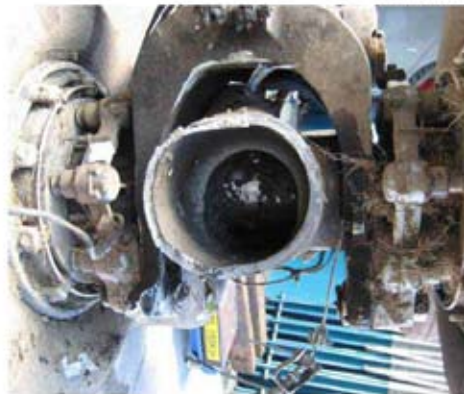
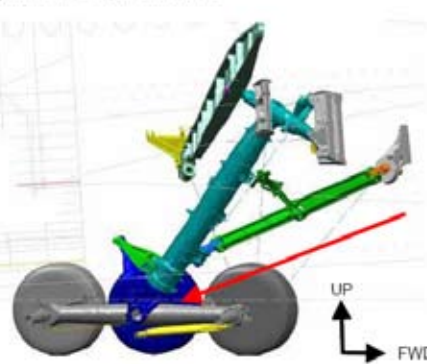
3. Subsequent ground slide: Truck beam fractured

Rear spar web and backup fitting failure and drag brace separation

Truck Beam reaches pitch up limit on Shock Strut/Inner Cylinder and fractures

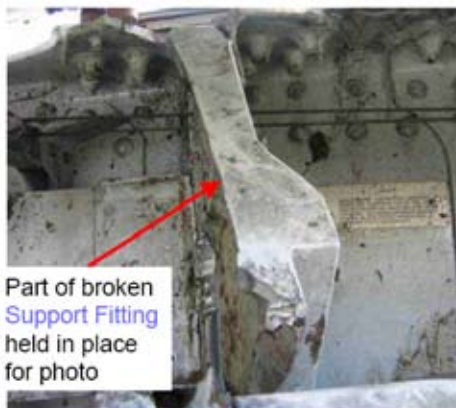
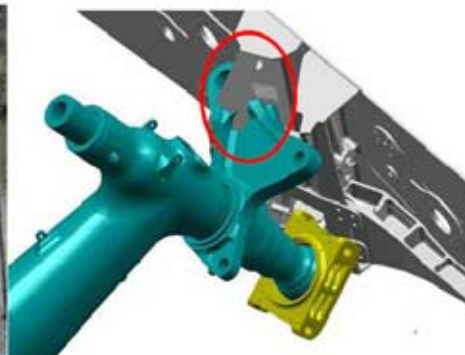
3. Shock Strut / Retract Arm Jams on and destroys upper part of inboard Trunnion Support Fitting

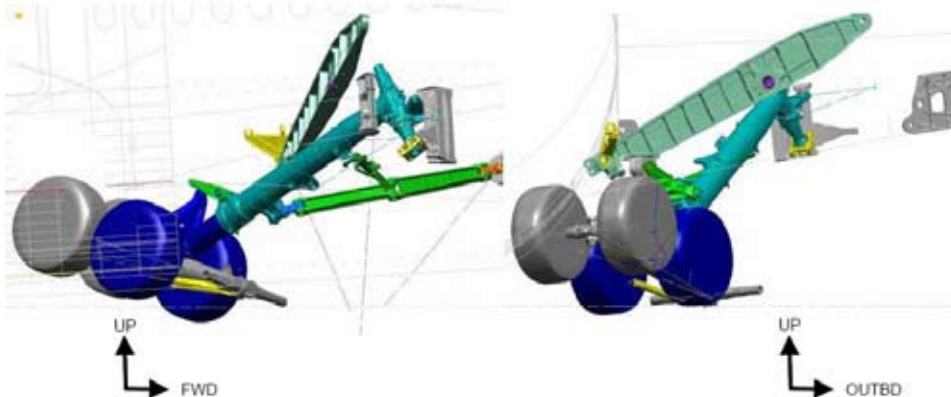
3. Gear twists on Shock Strut axis and Aft tires impinge on body.

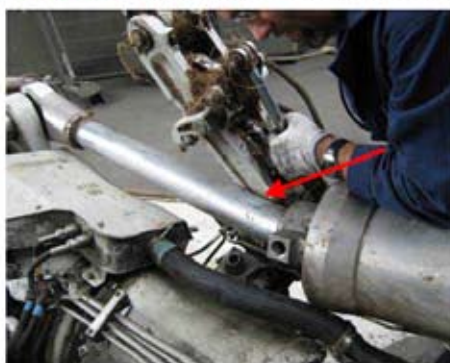
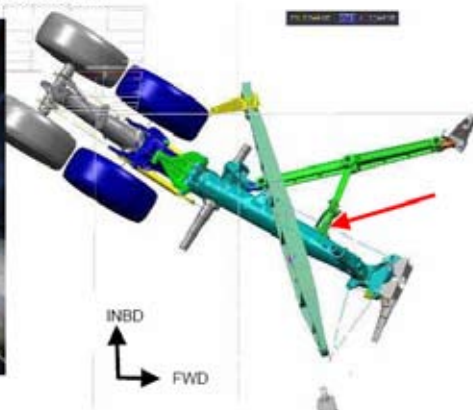
Gear continues twisting until Retract Actuator drives through Drag Brace Lock Link. Drag Brace separation – occurs sometime after this

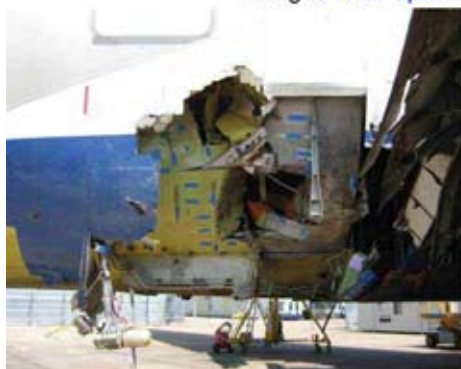
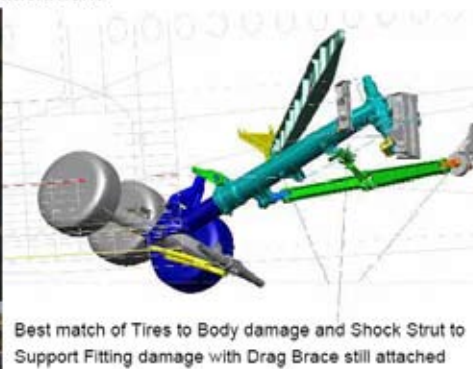
4. Aft Body impact completed after failure of Drag Brace Fitting to Rear Spar attachment

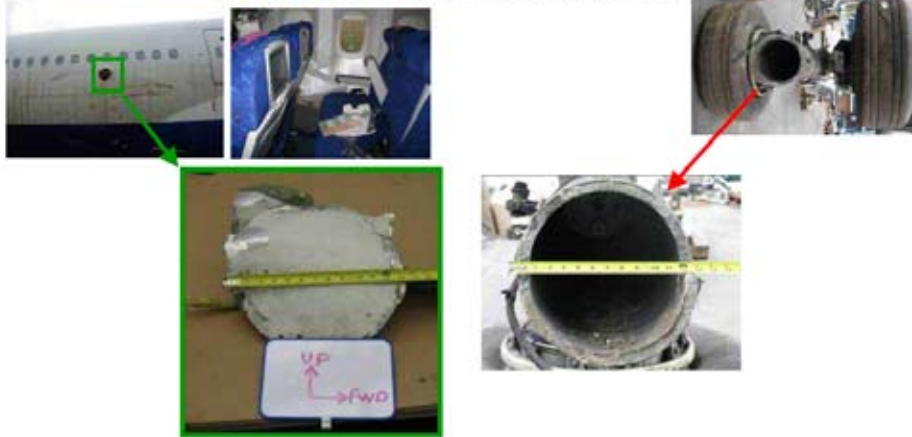
4. Fwd truck beam punctures fuselage skin

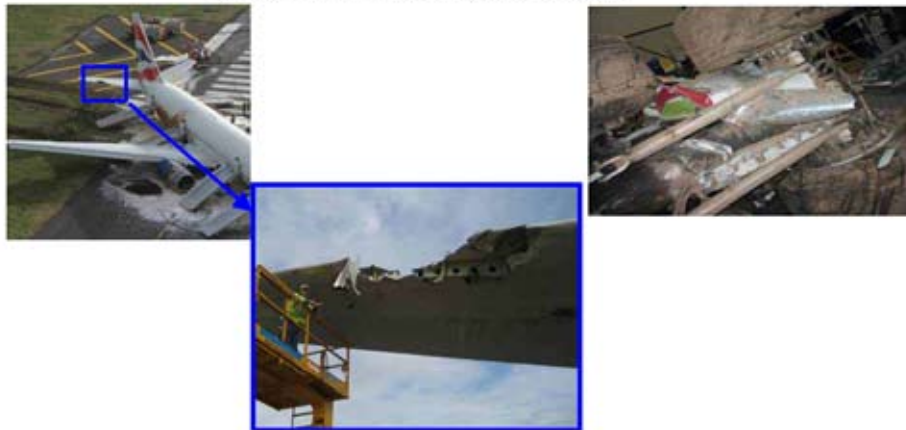
4. Right MLG strikes horizontal stabilizer

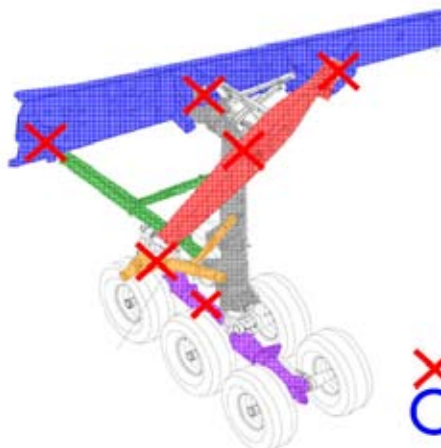
5. Final Configuration

- 6. Final Configuration
- Gear Beam separated
- Oleo and Trunnion separated
- Side Brace separated
- Truck Beam fractured
- Drag Brace separated

- X Joint Separated
- O Joint Remained Attached

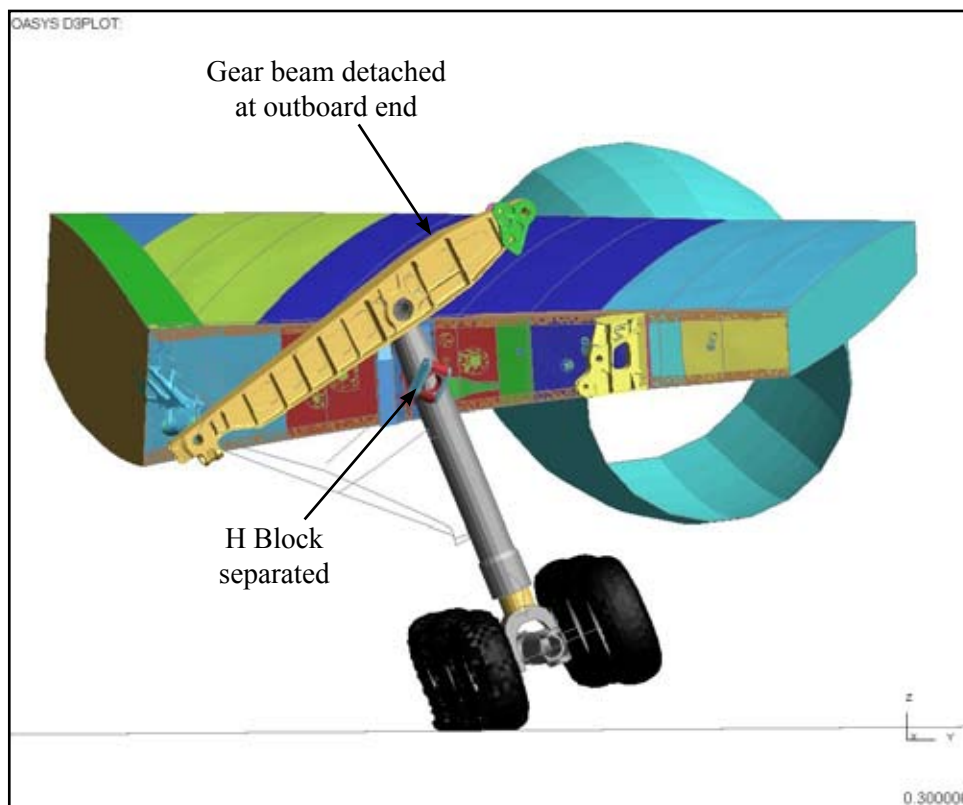
The first fuse pin failure occurred at the outboard end of the Gear Beam followed by failure of the fuse pins at the lower (H block) and upper housing positions. Thereafter, the gear beam rotated around its pivotal axis at the hanger link end. The drag brace fuse

Figure 66 shows a view from behind the right wing during the impact sequence, at the point when the outboard end of the gear beam and the lower and upper housings have failed.

View from rear of right wing – Run B (TIME = 0.30 SECS)

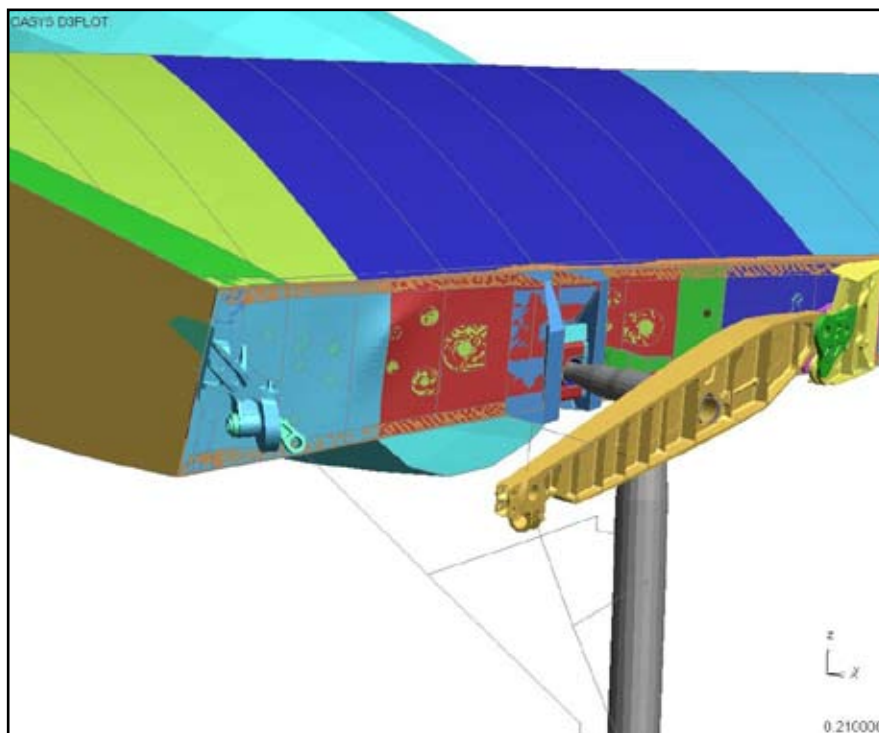
**Figure 67**

It was evident that the behaviour of the model on soft ground was different to that on a hard runway (Run B) in that only one fuse pin failed (the lower pin in the right outboard gear beam).

In the absence of any other fuse pin failures, loads could continue to be transferred into the rear spar. This led to distortion of both rear spars and is illustrated in Figure 67 which shows the right spar. A similar effect was seen in the left rear spar.

Right wing rear spar buckling – Run C (TIME = 0.21 SECS)

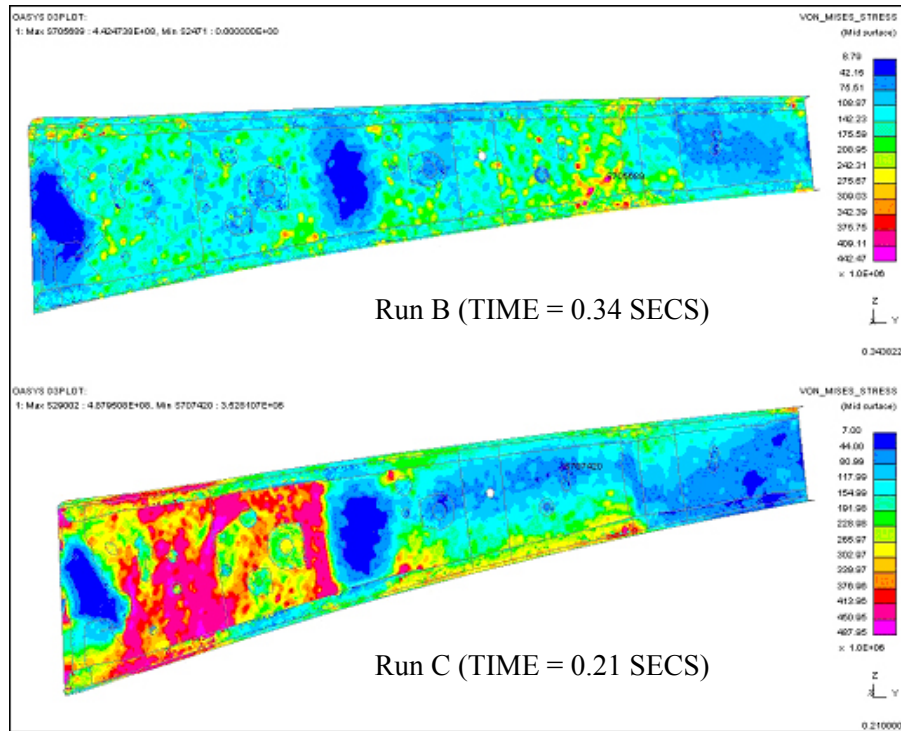
Figure 68 shows a comparison of the Von-Mises stress¹ in Run B (hard runway) and Run C; the red colours indicate higher stresses.

Right wing rear spar buckling Von-Mises stress

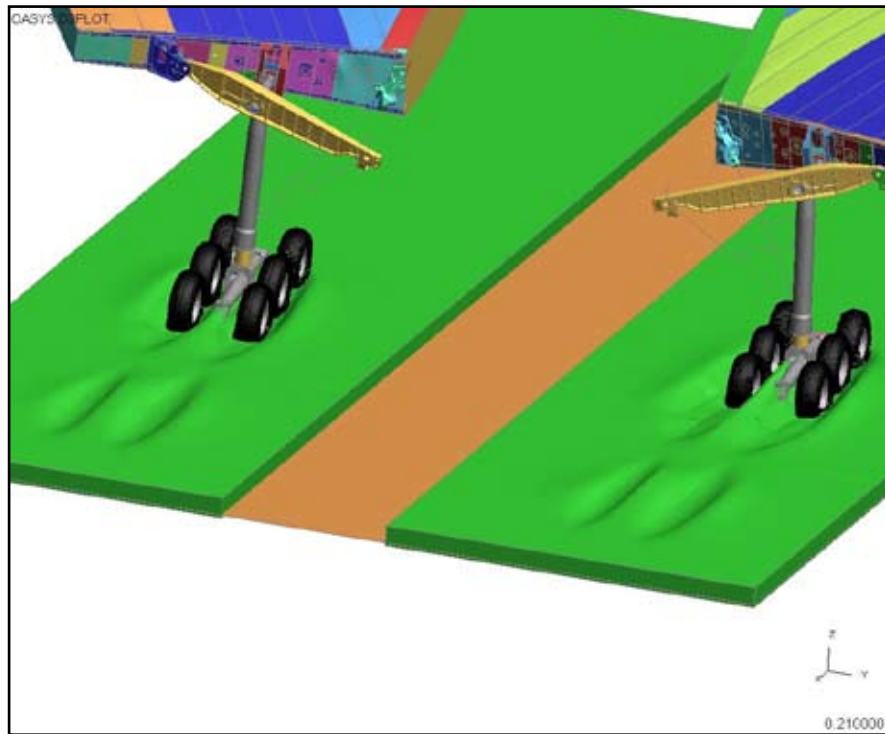
The Figure 69 shows the soft ground deformation.

Soft ground deformation Run C (TIME = 0.21 SECS)
